INTERIM REPORT OF THE U.S. DEPARTMENT OF ENERGY'S POWER OUTAGE STUDY TEAM

FINDINGS FROM THE SUMMER OF 1999

JANUARY 2000

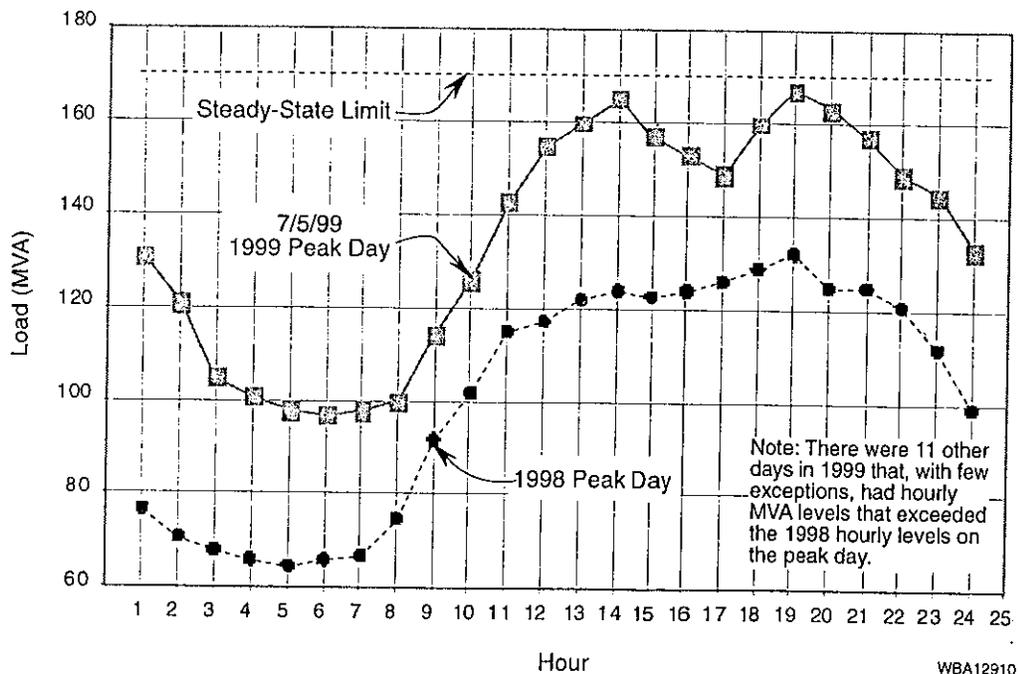
Figure 3 Long Island: Long Island Power Authority's Hourly Loads in the South Fork Area

Figure 3 shows plots of South Fork load versus time on the July 5, 1999 peak, and the 1998 peak. The figure also shows the maximum steady state-limit before voltage collapse.

The overloads were mostly a result of the rapid load growth across the system, especially in the South Fork area. Many of the smaller, older homes had been recently renovated and expanded, and the existing distribution system was inadequate for the new additional load. In the South Fork area, many large vacation residences had been built, and the population density was quite high for the holiday weekend. The South Fork is a peninsula that is only served by 69-kV lines for about its first 10 miles and then by 23-kV lines over the remaining distance of roughly 15 miles.

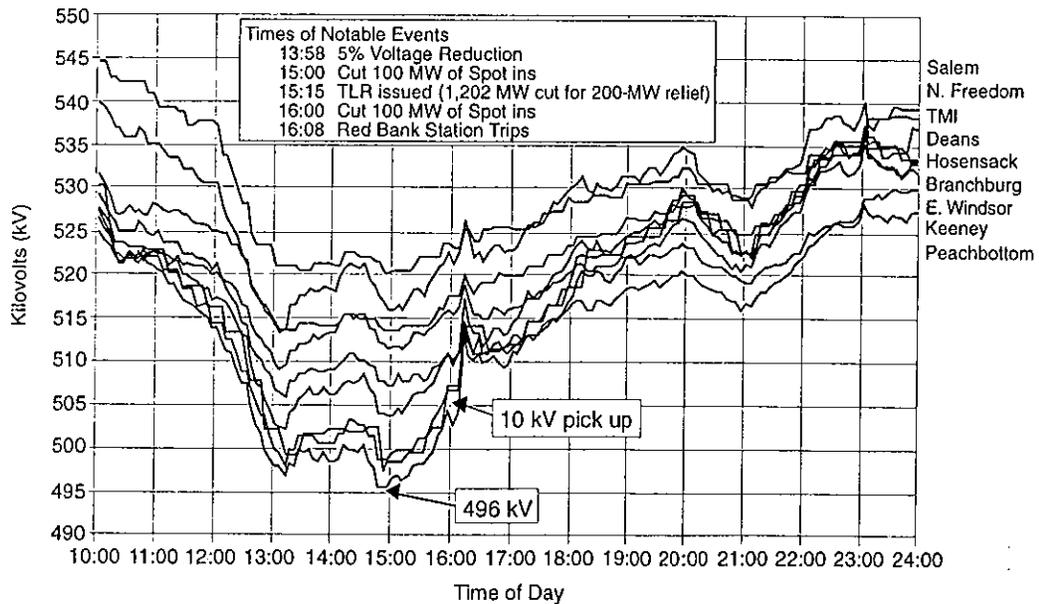
Figure 4 Mid-Atlantic Area: PJM Interconnection 500-kV Voltage Profile on July 6, 1999

Between 12:00 noon and 1:00 p.m. on July 6, voltages on the PJM system began to drop precipitously (Figure 4). PJM responded by taking its remaining, short-lead-time, interruptible customers off line, starting maximum emergency generation, issuing appeals for voluntary customer load curtailment, and curtailing emergency exports to NYPP.

Starting shortly after 1:00 p.m., voltages stopped dropping, and, in some areas, they began to recover. However, between about 1:00 and 4:00 p.m., voltages remained low. Moreover, they dropped slightly again just before 3:00 p.m., before they started to recover. During this period, PJM ordered a 5% voltage reduction. It also took actions to reduce the effect of parallel flows on its system by issuing a TLR on the eastern PJM-to-NYPP flowgate. The load loss that resulted from the outage at the Red Bank substation (described in the section on New Jersey) had a measurable beneficial impact on PJM system voltages, although by this time, system voltages were already recovering. By 10:21 p.m. that July 6 evening, the last emergency action taken by PJM was lifted. So on July 6, PJM had operated for 12 consecutive hours above its previous all-time load.

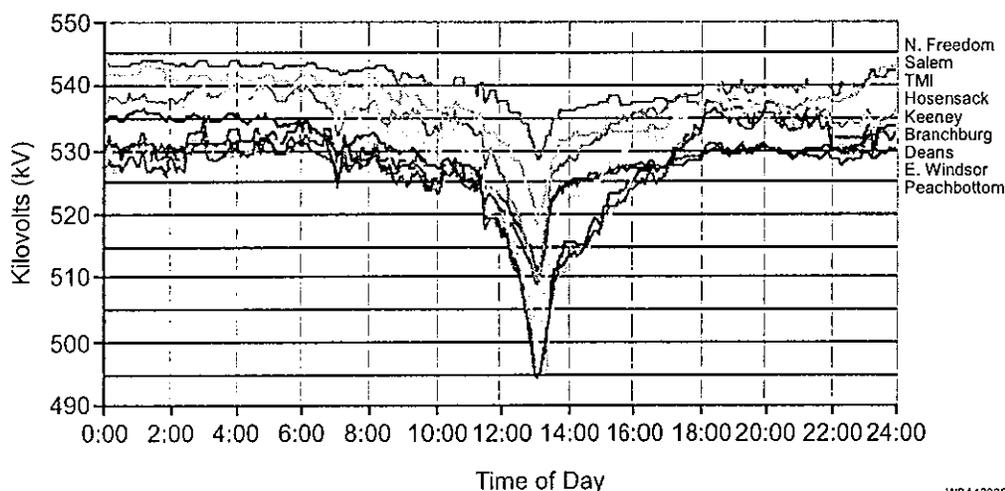
Figure 5 Mid-Atlantic Area: PJM Interconnection 500-kV Voltage Profile on July 19, 1999

On July 19, 1999, PJM experienced a similar drop in system voltages. Once more, the drop started at about 12:00 noon and reached a low point at about 1:00 p.m. (Figure 5). PJM implemented a series of actions that included a 5% voltage reduction, load management, increased eastern generation, and reduced imports from the west. In contrast to the slow restoration of voltages that occurred on July 6, on July 19, the system responded quickly, and normal voltages were restored within about one hour.

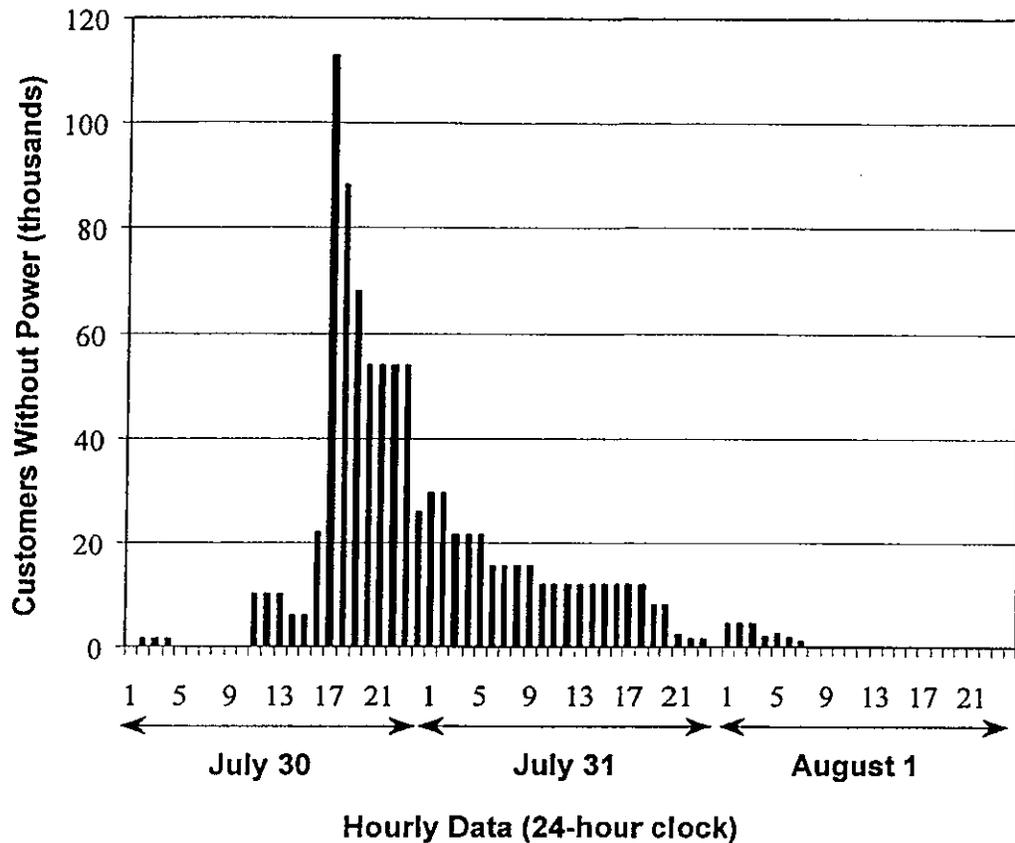
Figure 8 Chicago: Customer Outages Associated with Commonwealth Edison's Northwest Substation

On July 30, a modest number of customers were without power during the working hours; however, in the late afternoon (between 4:00 and 5:00 p.m.), the number of customers affected by the outage increased and remained quite high until midnight. Figure 8 traces the severity of the outage. The restoration process that proceeded through Saturday, July 31, and Sunday, August 1, is also evident in that figure.

The events that caused the loss of power to customers served by the Northwest substation related primarily to two classes of equipment: 12-kV cables and 12- to 4-kV transformers. The basic cause appears to have been 12-kV cable faults. In cases where the cable supplied a transformer, that transformer was de-energized with the cable. In other cases, de-energizing transformers, coupled with the overall high load conditions, overloaded other transformers. The units at the Northwest substation were protected by ComEd's Transformer Overload Relief Scheme, an automated process of relay actions that remove load from a transformer operating above its rated capacity. As a result of the

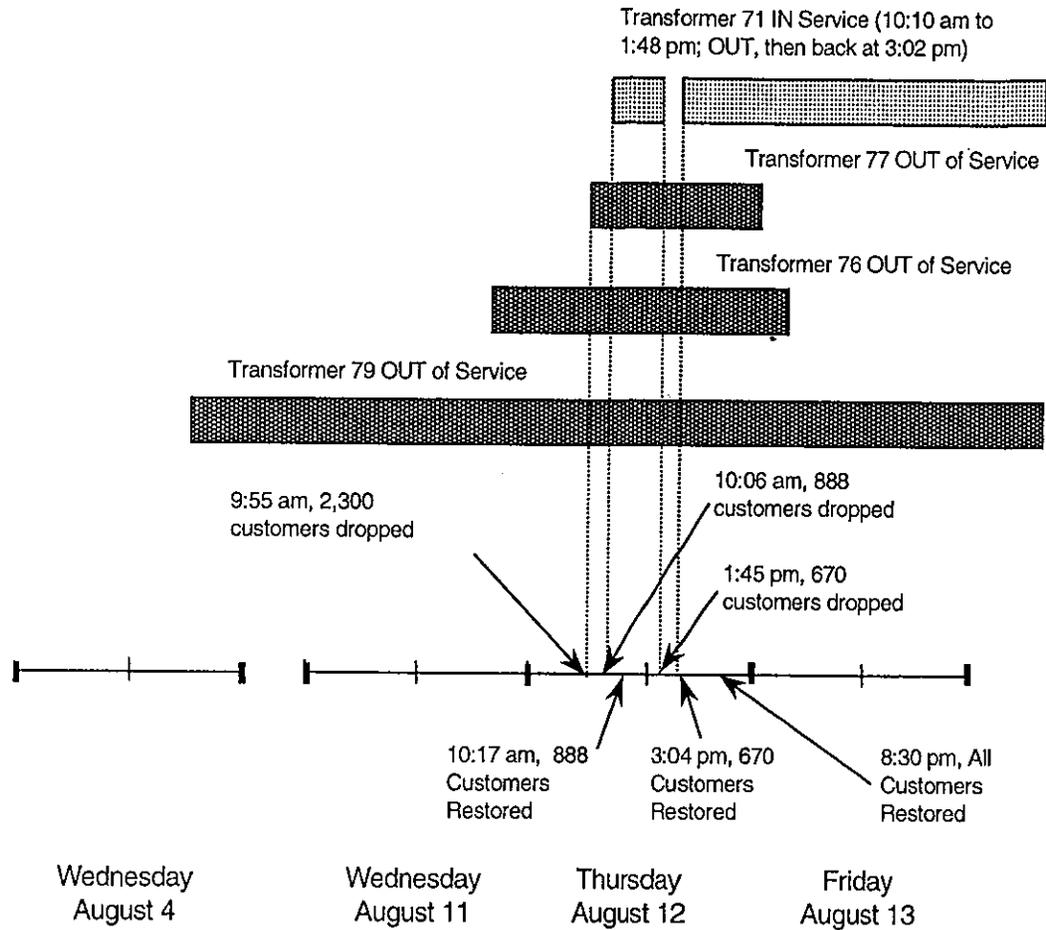
Figure 10 Chicago: Event Timeline for Commonwealth Edison's Jefferson Substation

At 4:19 p.m. on Wednesday, August 4, 1999, one transformer bank was removed from service because routine testing revealed evidence of overheating and arcing. The situation remained stable for one week, and the three remaining Jefferson transformer banks proved adequate to serve their load.

At 7:44 p.m. on Wednesday, August 11, a second transformer bank was automatically de-energized because of a fault on its associated 69-kV secondary cables. Inspection showed two failure points in the 69-kV cables. The substation was reduced to having only two operational transformer banks, each with a manufacturer's continuous power rating of 200 MVA. To put these ratings in perspective, consider that Jefferson substation's load had peaked earlier on this day (August 11) at 473 MVA. At 11 p.m., plans were made to shift load to the LaSalle substation so that demand would be removed from the 69-kV portion of the regional transmission system onto the 138-kV portion of the system.

On Thursday, August 12, at 9:39 a.m., one of the two remaining Jefferson transformer banks was automatically de-energized because of a fault on its 69-kV secondary cables. As a result, a single, 200-MVA-rated transformer was available for servicing the Jefferson load, which had reached a level of approximately 360 MVA at 9:30 a.m. To avoid overload and permanent damage to the remaining transformer bank, ComEd shut down its Vernon Park substation, which removed 2,300 customers and 55 MW of load from service at 9:55 a.m. At 10:06, additional load was intentionally shed by shutting down a section of the 12-kV distribution grid, which interrupted service to an additional 888 customers.

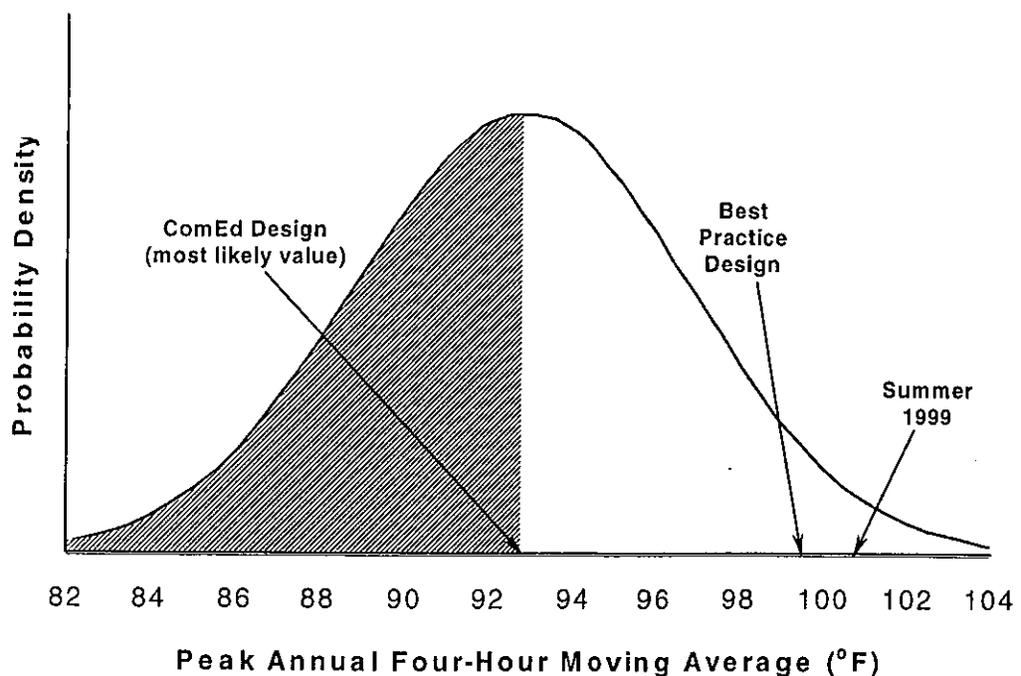
Figure 11 Chicago: Value for the Average of Extreme Weather Used by Commonwealth Edison for Forecasting

28. **Load forecasting techniques and associated distribution planning tools failed to adequately accommodate the effects of unusual summer weather conditions as experienced in 1999. (Reliability Metrics, Planning, and Tracking)** – Planning has been based on “average” weather conditions, meaning that load exceeds the design criterion approximately once in every 2 or 3 years (Figure 11). A criterion of 1 in 10 years is more commonplace in the industry. These shortcomings were compounded by further uncertainty in predictions for individual substation load levels. ComEd has now changed to a 99°F, four-hour moving-average peak temperature as a basis for planning.
29. **Emergency preparedness and management plans did not address distribution problems. (Operations Management and Emergency Response; Reliability Metrics, Planning, and Tracking)** – Although ComEd had an emergency plan for

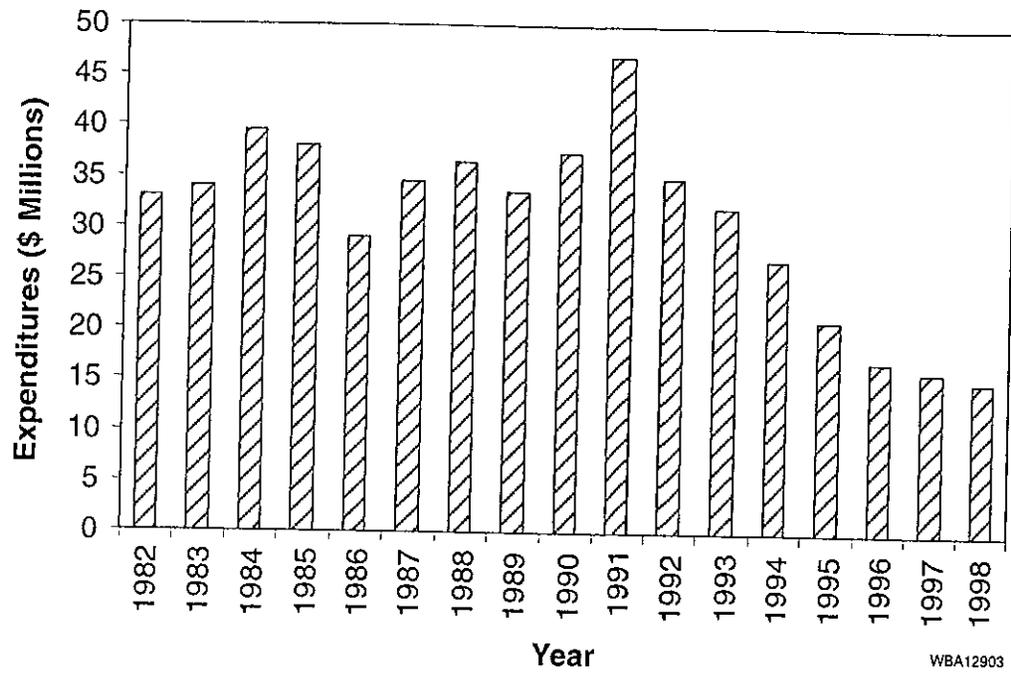
Figure 12 Chicago: Annual Substation Maintenance Expenditures for Commonwealth Edison

37. **Transmission and distribution maintenance expenditures declined over time and became inadequate. (Transition to Competitive Energy Service Markets; Regulatory Policy for Reliable Transmission and Distribution)** – T&D maintenance expenditures declined dramatically and consistently from 1991 to 1998 (e.g., see the annual substation maintenance expenditures shown in Figure 12). The decline coincided with other cost pressures faced by ComEd, including those associated with nuclear plant maintenance and industry restructuring.

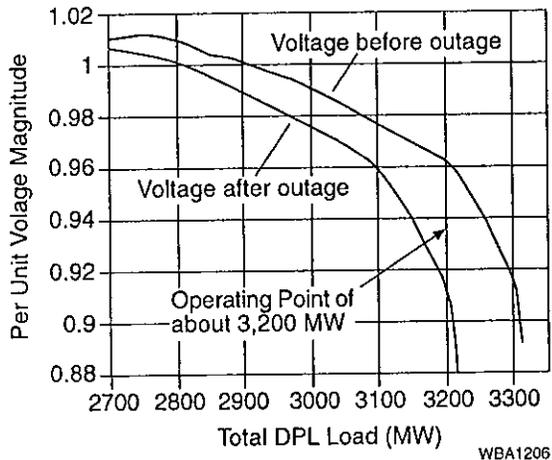
Figure A.1 Delmarva Peninsula: Power Voltage Curves for Delmarva Power & Light Company's Lewes Substation 69-kV Voltage before and after the Indian River 2 Generator Outage

Such high sensitivity of bus voltages to real and reactive power generation is often associated with a system that is operating near its point of maximum loadability. This aspect of system performance can be represented through a power voltage (PV) curve, which shows the variation in bus voltage magnitudes with respect to bus or system load.

Figure A.1 shows the curves for 69-kV voltage at the Lewes substation when IR2 was in service and out of service. These curves were developed by solving multiple power flows for each situation and then plotting the Lewes substation 69-kV voltage. Note that when IR2 is out of service, the system operating point of 3,200 MW is very close to the point of maximum loadability, when voltages could collapse toward zero, and emergency actions would be needed to avoid catastrophic failure.
