**U.S.-Canada Power System Outage Task Force**

**Interim Report:  
Causes of the  
August 14th Blackout  
in the  
United States and Canada**

**November 2003**

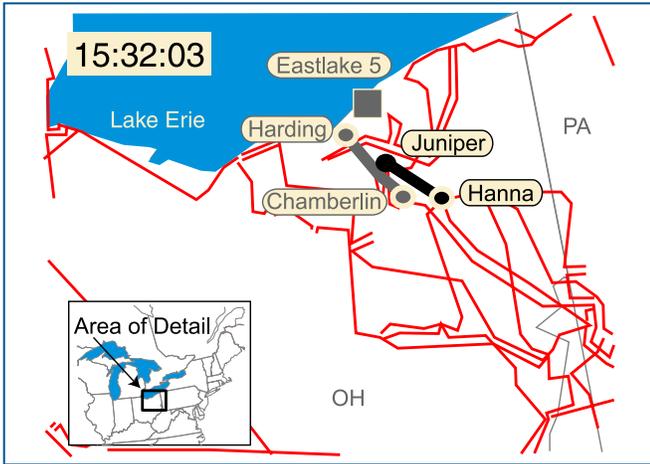
**Figure 4.9. Hanna-Juniper 345-kV Line**

Hanna-Juniper was loaded at 87.5% of its normal and emergency rating when it tripped. With this line open, almost 1,000 MVA had to find a new path to reach its load in Cleveland. Loading on the remaining two 345-kV lines increased, with Star-Juniper taking the bulk of the power. This caused Star-South Canton's loading to rise above its normal but within its emergency rating and pushed more power onto the 138-kV system. Flows west into Michigan decreased slightly and voltages declined somewhat in the Cleveland area.

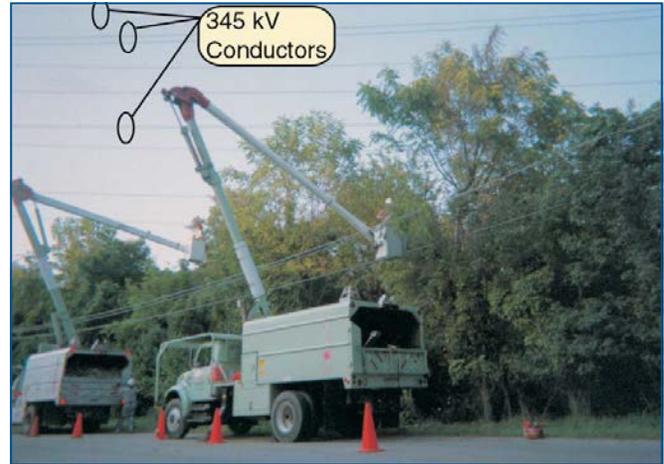
**Figure 4.10. Cause of the Hanna-Juniper Line Loss**

This August 14 photo shows the tree that caused the loss of the Hanna-Juniper line (tallest tree in photo). Other 345-kV conductors and shield wires can be seen in the background. Photo by Nelson Tree.
