2014 FIDVR Events Analysis on Valley Distribution Circuits

Engineering & Technical Services, Advanced Technology

June 19, 2015

2014 FIDVR Event Analysis on Valley Distribution Circuits

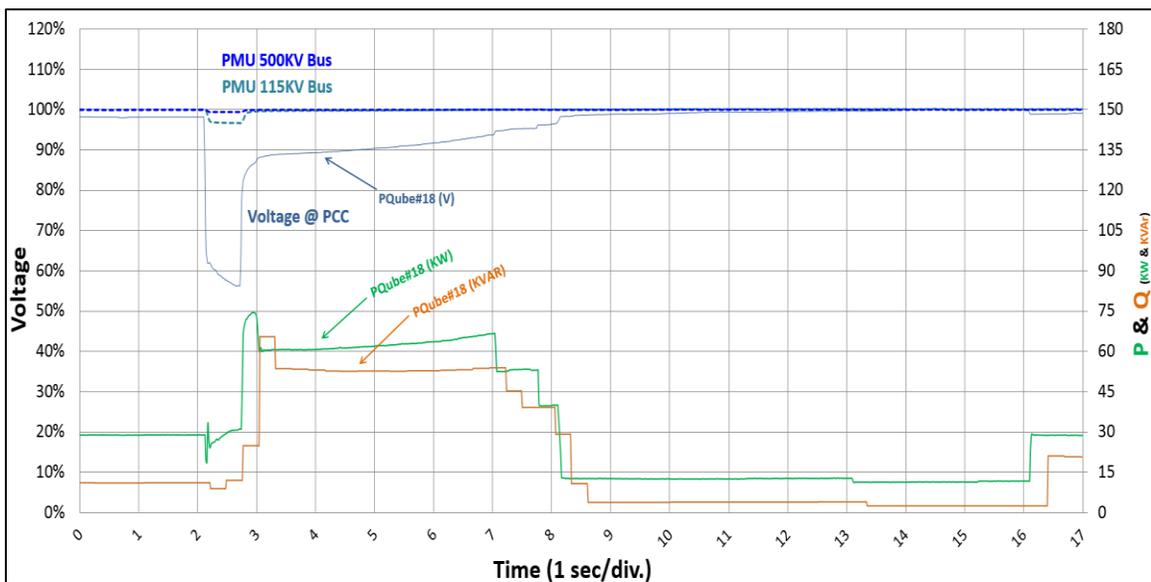
Figure 6.1.1 FIDVR Event #1 (July 7, 19:57 PDT) RMS Data [PQ 18]

- The event lasted approximately 6 seconds until distribution voltage finished recovering to its pre-event condition
- Most of the loads begin disconnecting 5 seconds after the fault occurs due to RAC's thermal protection
- Approximately 60% of the load was ultimately lost 12 seconds after the event began
- A portion of customer load restarted shortly after the 16 second mark on the provided figure below

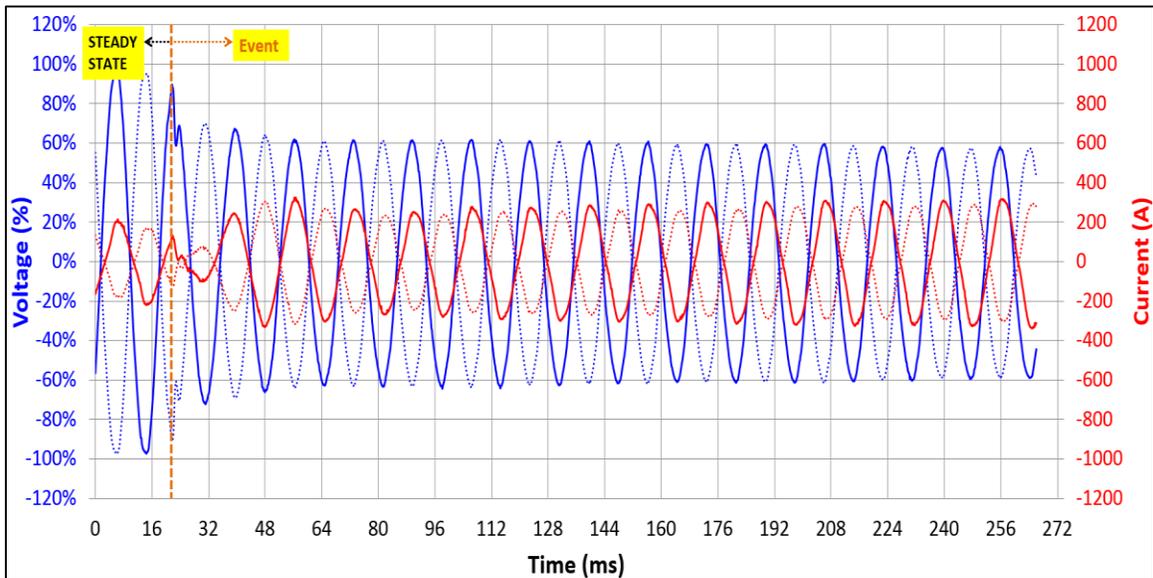
Figure 6.1.2 FIDVR Event #1 (July 7, 19:57 PDT) Sinusoidal Data [PQ 18]

The sinusoidal waveform data from the PQ 18 device, shown in Figure 6.1.2, indicates that the fault occurred at the 80 degree angle mark of the Line 1 voltage waveform. Although peak current increases slightly, it does not appear that the sinusoidal data captures fully stalled loads. The RMS data indicates that this sudden increase in real and reactive load occurs outside the window of the recorded sinusoidal waveform data.

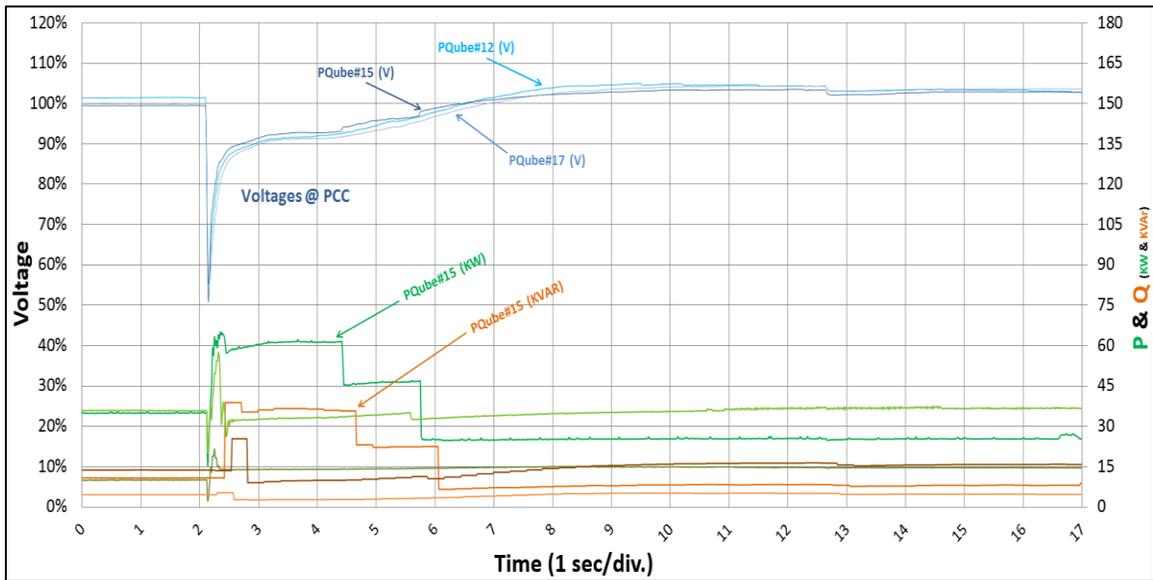
Figure 6.2.1 FIDVR Event #2 (September 12, 12:55 PDT) RMS Data [PQ 12, 15, and 17]

The Grid Control Center (GCC) reported a fire of undetermined origin burning under and past a 500 kV line on the system. At 12:55, a fault was indicated and the 500 kV line relayed as a result. The RMS data for Event #2 shown in Figure 6.2.1 exhibits these characteristics:

- The event spread through the distribution system as evidenced by the multiple PQ device recordings at different monitoring locations
- During the fault captured, the voltages at the PCC drop to as low as 51% of nominal where RACs appear to stall at one of PQ devices
- Real power (P) and reactive power (Q) at PQ 15 increased as such
 - $P = 1.6X$ at $V = 88\%$ within 1 second after the fault
 - $Q = 3.7X$ at $V = 88\%$ within 1 second after the fault
- The various circuits took approximately 4.5 seconds respectively for voltage to recover to their pre-event conditions
- Stalled loads begin disconnecting a couple seconds after the fault
- Approximately 29% of the load was lost due to RAC's thermal protection by the 7 second mark shown on Figure 6.2.2
- The loss of load provoked a maximum over-voltage of 5% above nominal on the assorted distribution circuits

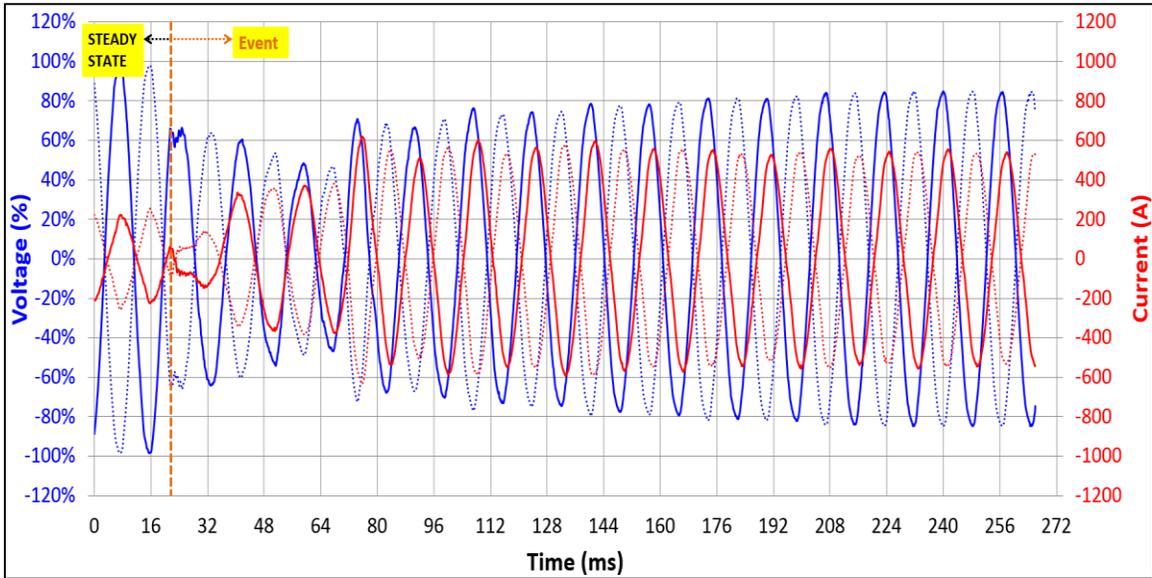
Figure 6.2.3 FIDVR Event #2 (September 12, 12:55 PDT) Sinusoidal Data [PQ 15]

The sinusoidal waveform data from the PQ 15 device, shown in Figure 6.2.3, indicates that the fault occurred at the 40 degree angle of the Line 1 voltage waveform. Stalling appears to occur in approximately 3 cycles after the event begins as indicated by the

peak current dramatically increasing and the power factor changing. The current is nearly 220 amps-peak before the event and as high as 620 amps-peak during the event.

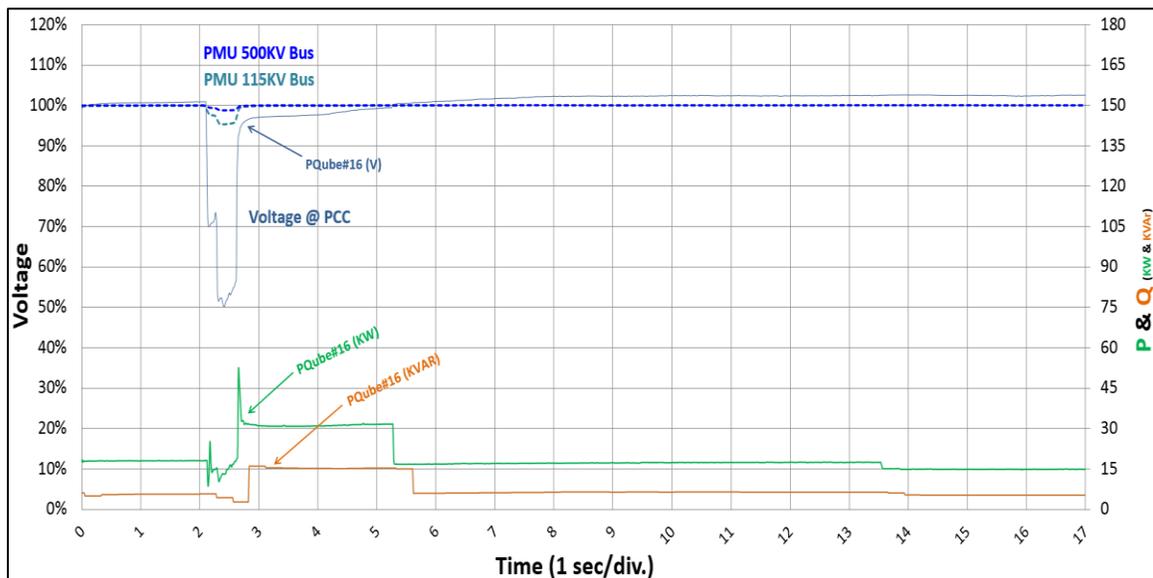
Figure 7.1.1 Event #1 (May 16, 23:34 PDT) RMS Data [PQ 16]

- **No significant delayed voltage recovery** or over-voltage was recorded
- The event caused a minor voltage deviation on the sub-transmission systems as evidenced by the PMU data in the Valley region. Nevertheless only a single PQ device captured an under-voltage profile on the distribution system.
- The voltage at the PCC decreased to 70% during the initial fault. As voltage began to recover, another fault occurred dropping the secondary voltage to as low as 50%.
- PMU data shows the sub-transmission voltage decreasing slightly to 95% of nominal

- Real power (P) and reactive power (Q) as such
 - $P = 2.9X$ at $V = 55\%$ within 1 second of the fault (as voltage is about to recover)
 - $Q = 2.8X$ at $V = 55\%$ within 1 second of the fault (as voltage is about to recover)
- Distribution voltage completely recovers to pre-event voltage in approximately 3.15 seconds. However, this voltage is nearly completely recovered (97% of nominal) within the 1st second of the event.
- Loads begin disconnecting and/or restarting approximately 3 seconds after the initial under-voltage event occurs
- Approximately 8% of load was lost (based on pre-event load) immediately following the voltage recovery, and an additional 10% of load was lost several seconds later
- Air conditioner load was likely low during the time of this particular event

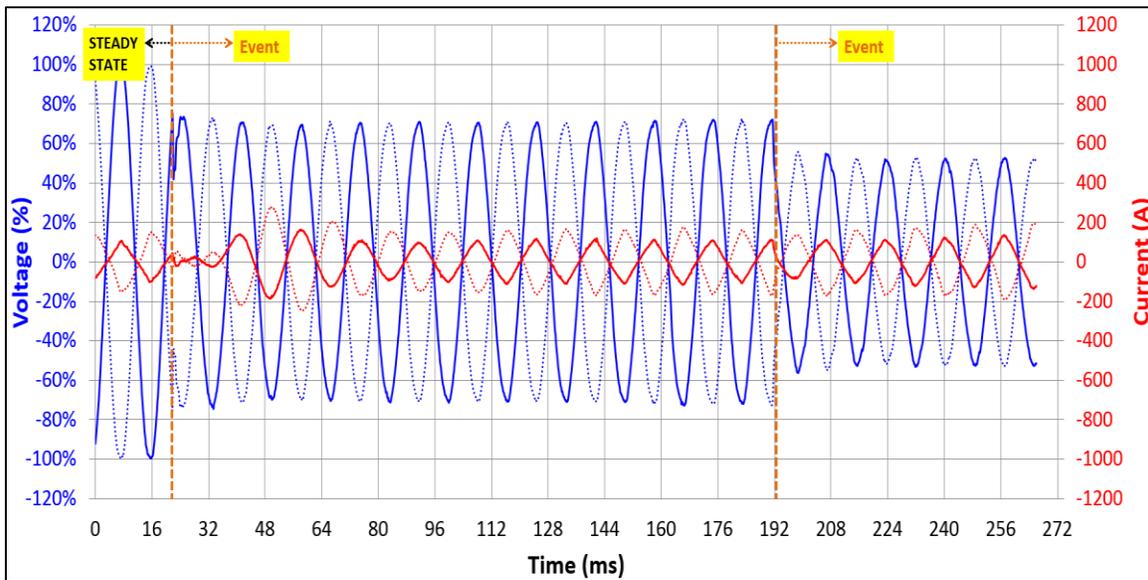
Figure 7.1.2 Event #1 (May 16, 23:34 PDT) Sinusoidal Data [PQ 16]

The sinusoidal waveform data from the PQ 16 device indicates that the first fault occurred at the 50 degree angle of the Line 1 voltage waveform and the second fault at the 100 degree angle of Line 1 voltage. Peak current increases slightly for a brief time, but no

significant increase in current is captured. The RMS data indicates that the increase in real and reactive load occurs outside the window of the recorded sinusoidal data.

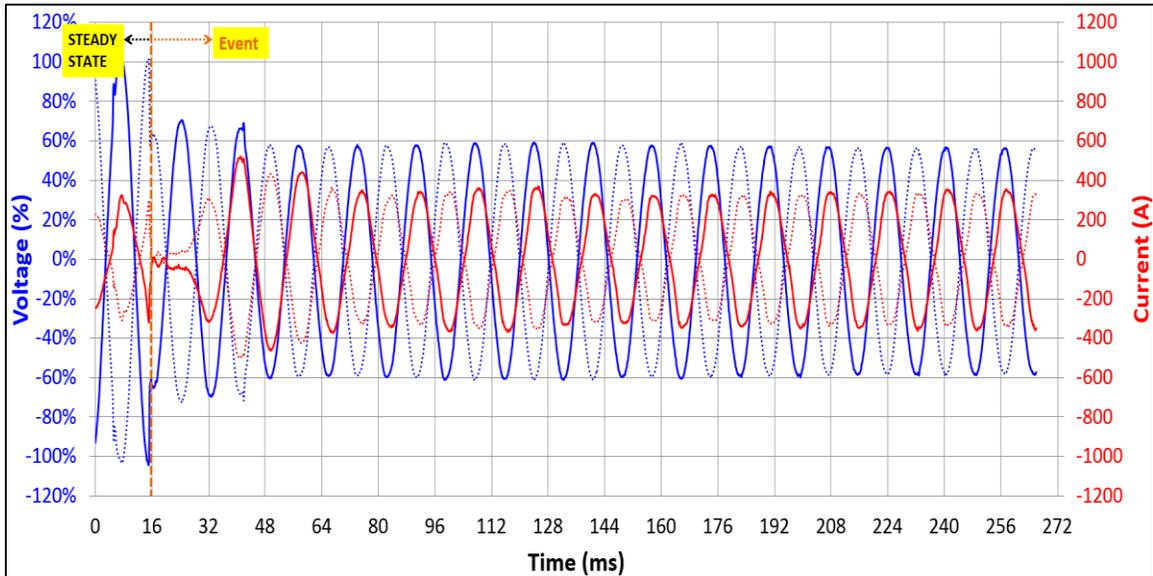
Figure 7.2.2 Event #2 (June 30, 18:49 PDT) Sinusoidal Data [PQ 19]

The sinusoidal waveform data from the PQ 19 device indicates that the fault occurred at the 90 degree angle of the Line 2 voltage waveform. The peak current values do increase slightly during this transient. However, the RMS data indicates that the condition where loads are completely stalled occurs outside the window of the recorded sinusoidal waveform data.

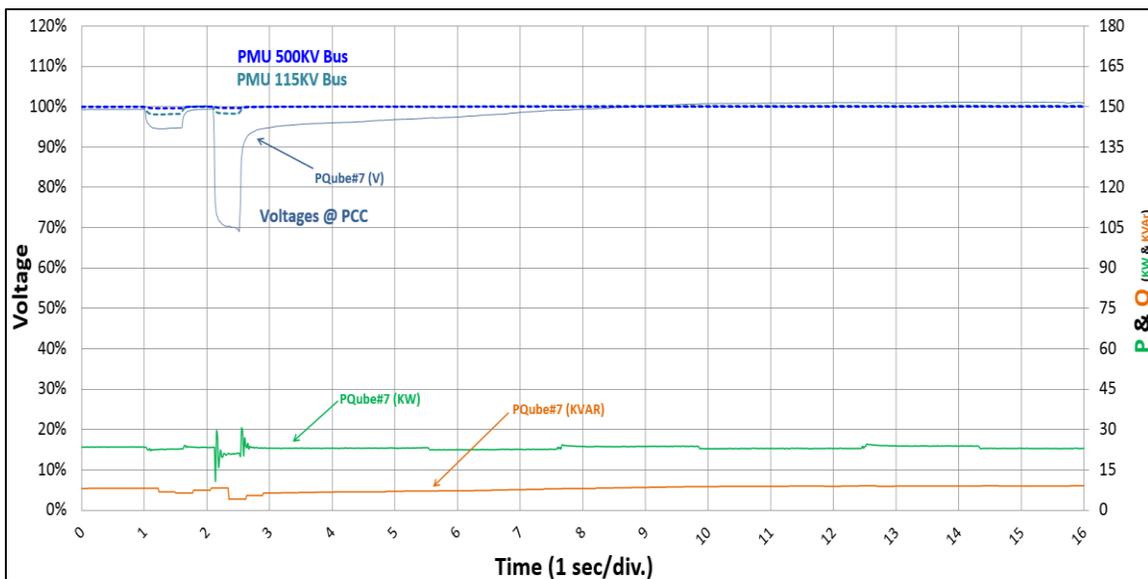
Figure 7.3.1 Event #3 (July 29, 15:15:11 PDT) RMS Data [PQ 7]

- The event caused a minor voltage deviation on the sub-transmission system as evidenced by the PMU data, but only a single PQ device captured an under-voltage profile from the monitored locations
- Voltage at the PCC drops to 95% during the first fault observed and then as low as 69% of nominal during the second fault
- After the second fault, voltage recovers to 92% with 0.5 seconds and then to nominal in another 5.5 seconds
- **No stalling behavior was observed at the monitoring location** (customers served from this padmount transformer may have not been running their A/C units)
- No over-voltage was observed after this event

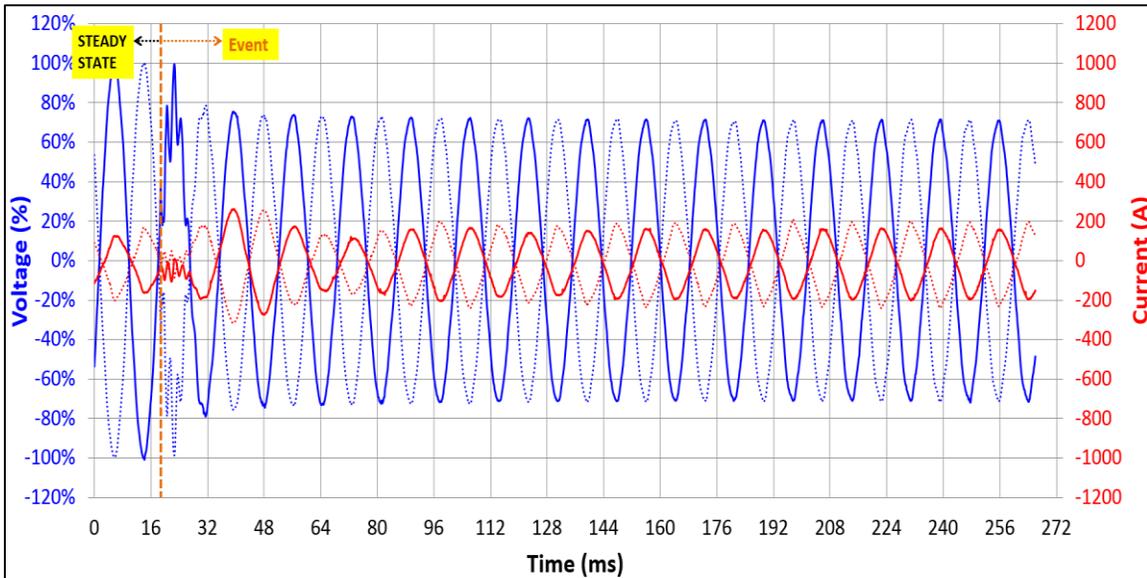
Figure 7.3.2 Event #3 (July 29, 15:15:11 PDT) Sinusoidal Data [PQ 7]

The sinusoidal waveform data from the PQ 7 device indicates that the fault occurred at the 15 degree angle of the Line 1 voltage waveform. Other than a brief increase within the first couple cycles of the transient, no significant response is observed from the current.

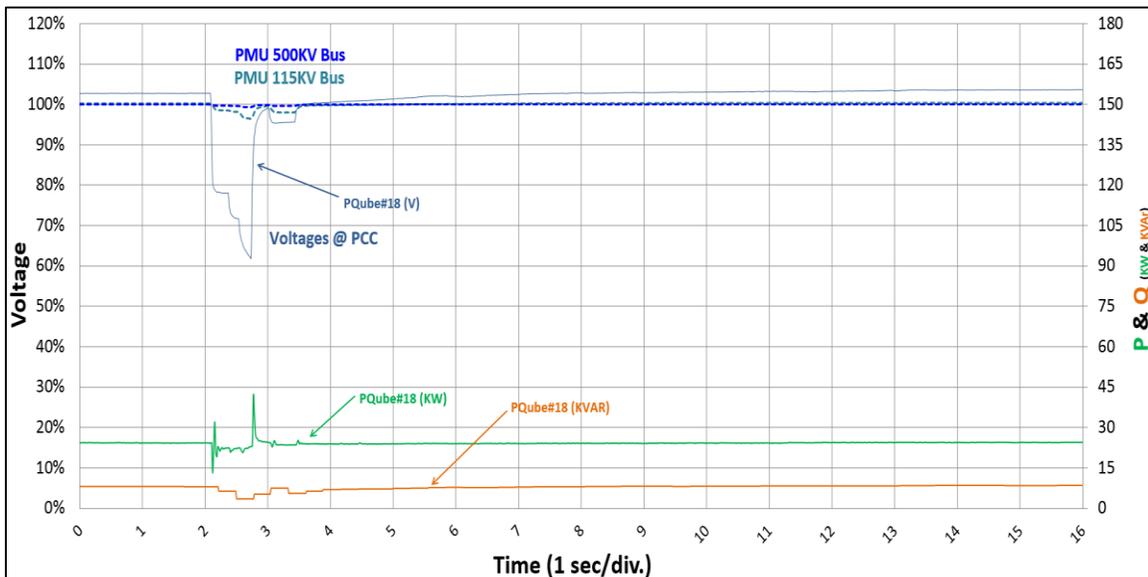
Figure 7.4.1 Event #4 (July 29, 15:15:27 PDT) RMS Data [PQ 18]

- The event caused a minor voltage deviation on the sub-transmission system as evidenced by the PMU data, but now a different PQ device captured an under-voltage at the PCC
- Voltage at the PCC decreases in steps, dropping as low as 62% of nominal
- **No delayed voltage recovery or stalling observed during this event** (customers served from this padmount transformer may have not been running their A/C units)

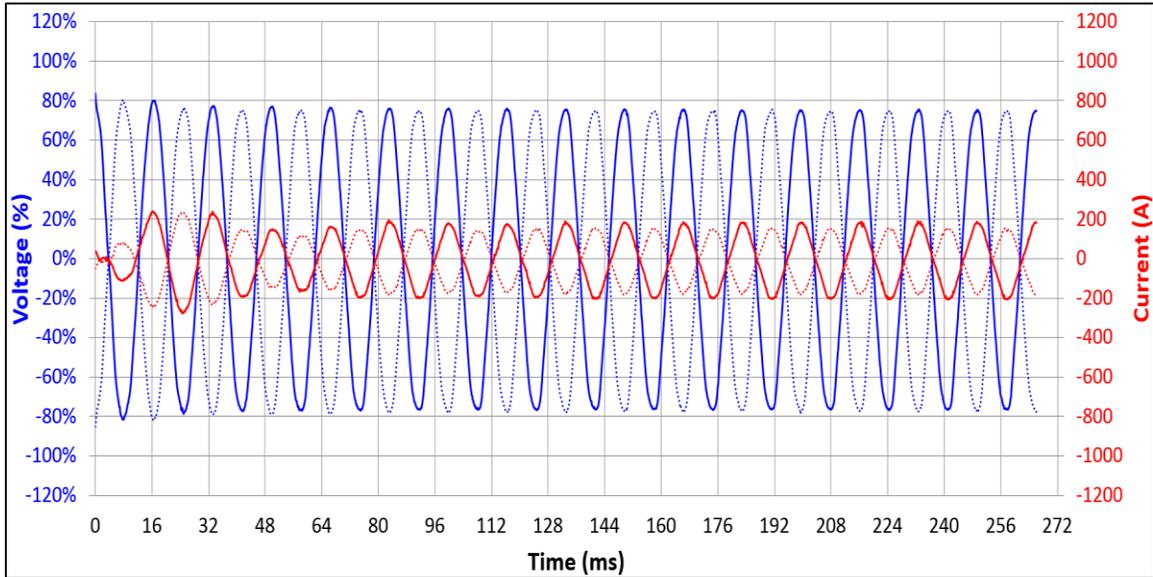
Figure 7.4.2 Event #4 (July 29, 15:15:27 PDT) Sinusoidal Data [PQ 18]

The sinusoidal waveform data from the PQ 18 device failed to capture the beginning of the fault. Additionally, no stalling behavior was observed during this event resulting in no significant response from the current waveforms.

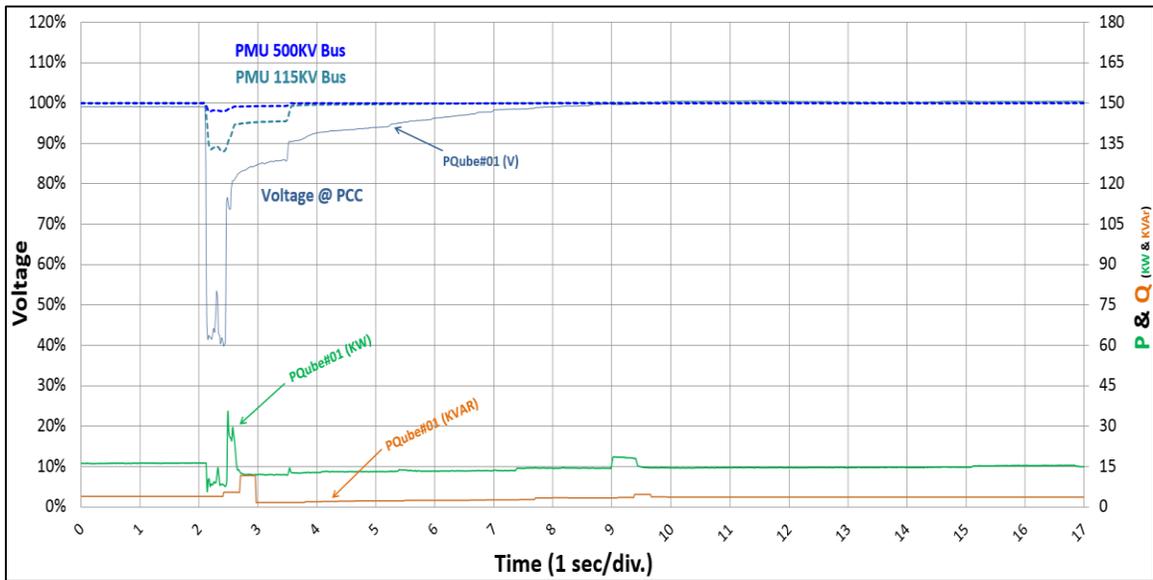
Figure 7.5.1 Event #5 (August 2, 10:41 PDT) RMS Data [PQ 1]

- The event captured did influence the sub-transmission system as observed by the PMU data captured in the Valley region. However one of the installed PQ devices captured an under-voltage recovery event at the distribution level

- The real and reactive power at this padmount installation monitoring site **do not appear to have sufficient load stalling**
- The voltage profile suggests that this could possibly be a localized FIDVR event with load stalling on adjacent padmount transformers (not being monitored) and/or circuits where there may be more air conditioner load. However, this cannot be confirmed since voltage data from neighboring padmounts or circuits was not observed at this resolution.

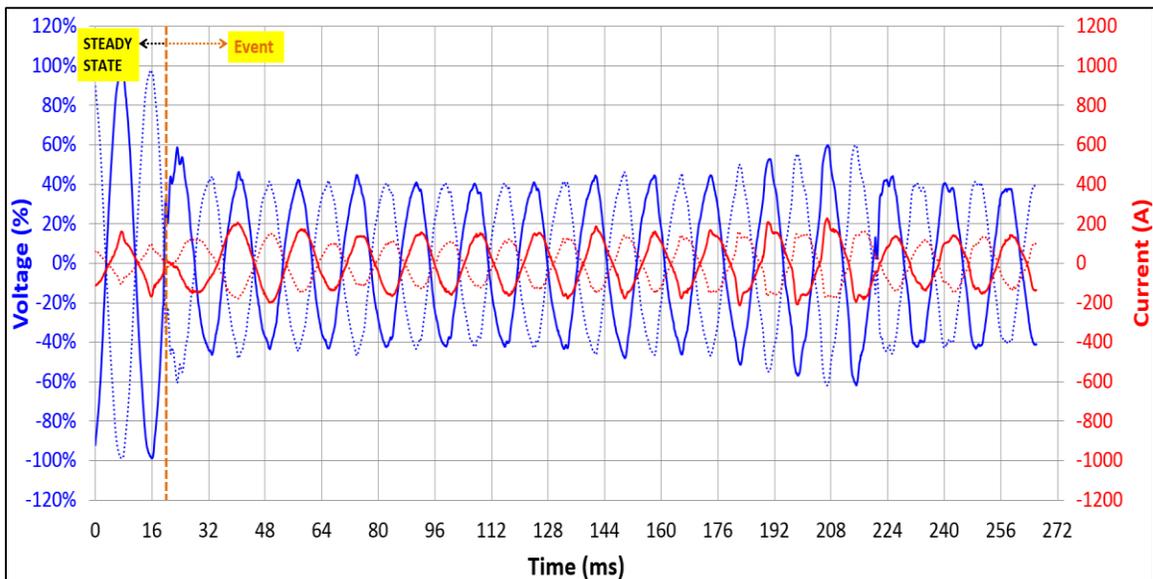
Figure 7.5.2 Event #5 (August 2, 10:41 PDT) Sinusoidal Data [PQ 1]

The sinusoidal waveform data from the PQ 1 device indicates that the fault occurred at the 10 degree angle of the Line 1 voltage waveform. Immediately after the fault, the current waveform begins leading voltage before returning to a lagging condition a couple cycles later. No stalling is observed from the sinusoidal waveforms.

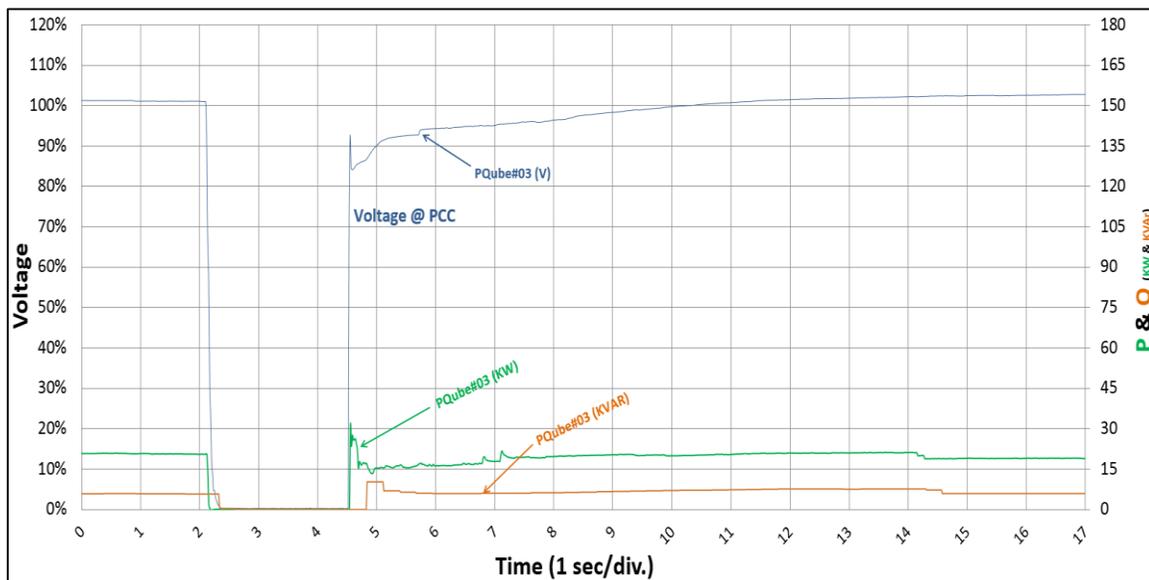
Figure 7.6.1 Event #6 (August 11, 13:54 PDT) RMS Data [PQ 3]

This event was captured from PQ device 3 located on phase A of a circuit within the section C&D bus. Records from the Grid Control Center (GCC) indicate that two 115 kV lines out of a single substation relayed and reclosed with the cause under investigation. The RMS data for this event shown in Figure 7.6.1 exhibited the following characteristics:

- Voltage is decreased to 0% for over two seconds as observed at the monitoring location
- After reclosing occurs, voltage takes approximately another 5 seconds to fully recover
- Although the under-voltage event was extremely low, **it did not provoke load stalling at the monitoring location** despite temperatures in the mid 80°s
- No significant over-voltage behavior was captured during this event

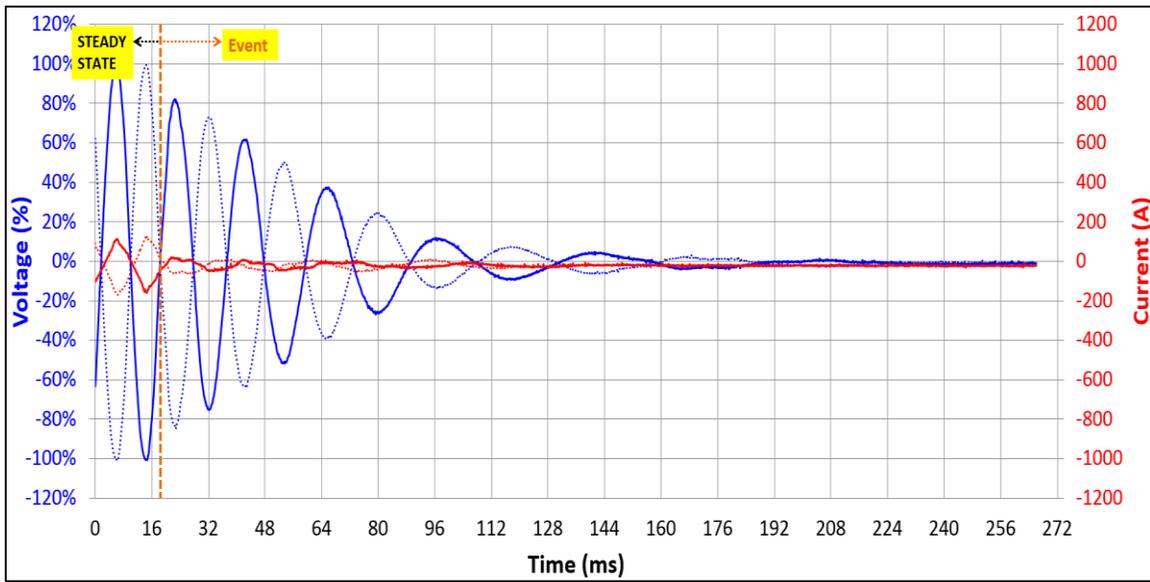
Figure 7.6.2 Event #6 (August 11, 13:54 PDT) Sinusoidal Data [PQ 3]

The sinusoidal waveform data from the PQ 3 device indicates that the fault occurred at 0 degree angle (or zero crossing) of the Line 1 voltage waveform. Voltage falls to zero in several cycles and recovery is not captured in the limited window (approximately 16 cycles) of the sinusoidal event data.

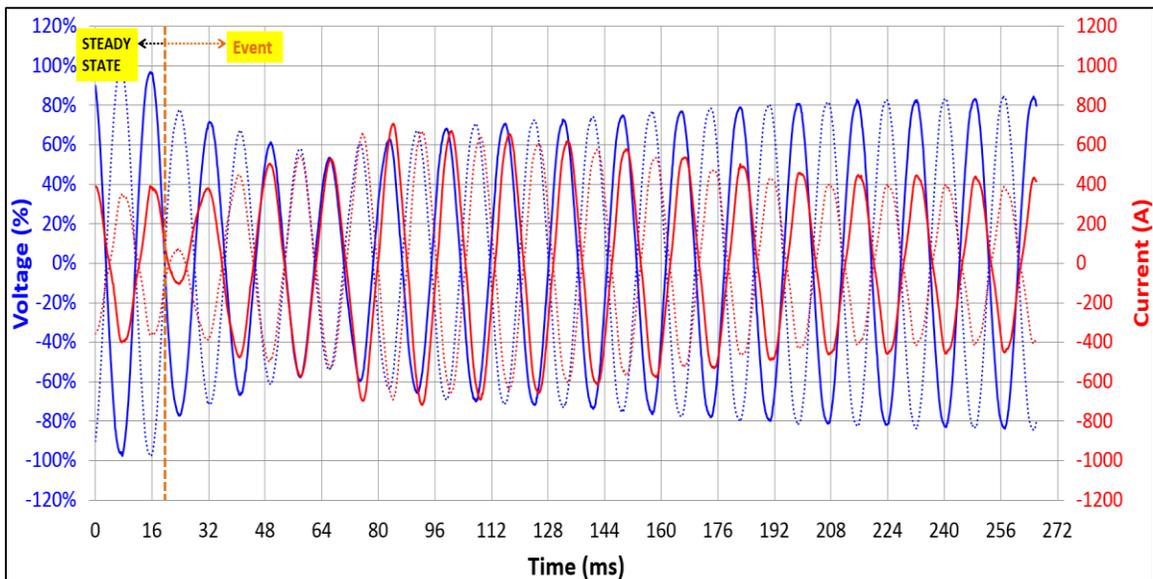
Figure 7.7.2 Event #7 (September 16, 14:36 PDT) Sinusoidal Data [PQ 17]

The sinusoidal waveform data from the PQ 17 device indicates that the fault occurred near the zero crossing of the voltage waveform. Although peak current increases momentarily within several cycles following the fault, it does not appear that the sinusoidal data captures stalled loads.

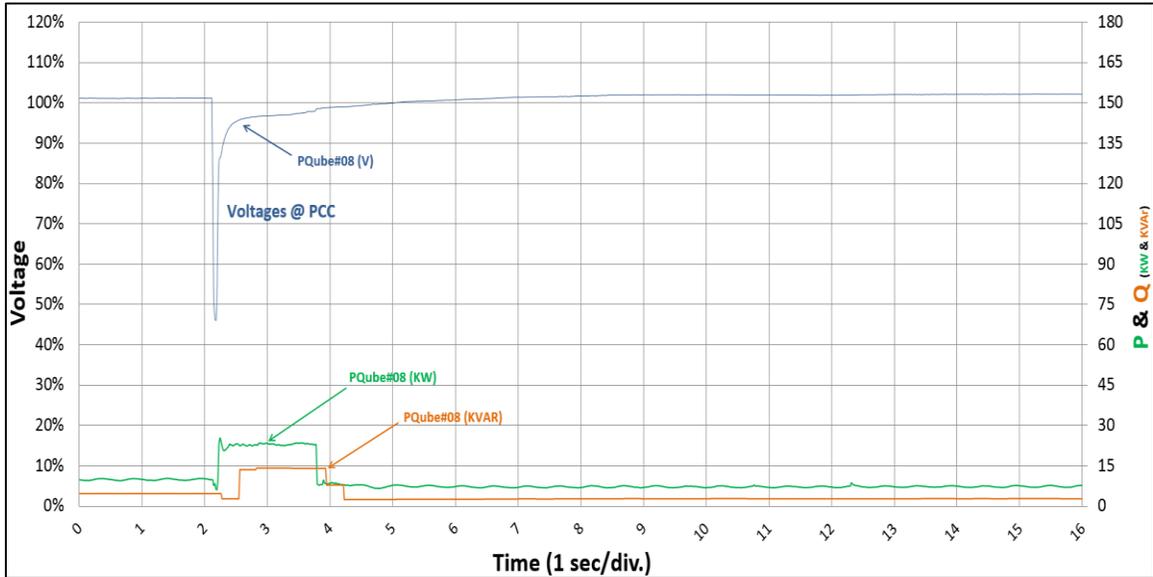
Figure 7.8.1 Event #8 (October 24, 15:34 PDT) RMS Data [PQ 8]

- **No significant delayed voltage recovery** was recorded during this event
- Voltage drops to as low as 46% of nominal as observed by PQ 8 at the PCC
- It took approximately 3 seconds for voltage to recover (recovered to 95% of nominal within the first second)
- Real power (P) and reactive power (Q) increased as such
 - $P = 2.3X$ at $V = 96\%$ within 1 second after the fault
 - $Q = 3X$ at $V = 96\%$ within 1 second after the fault
- Possibly stalled load(s) disconnect and/or restart within 2 seconds of the fault
- This event caused loss in load of approximately 25% to 30% in load after fault
- Although this undervoltage transient may have stalled load on a single circuit, it did not provoke a FIDVR event, likely due to a low amount of distributed A/C load

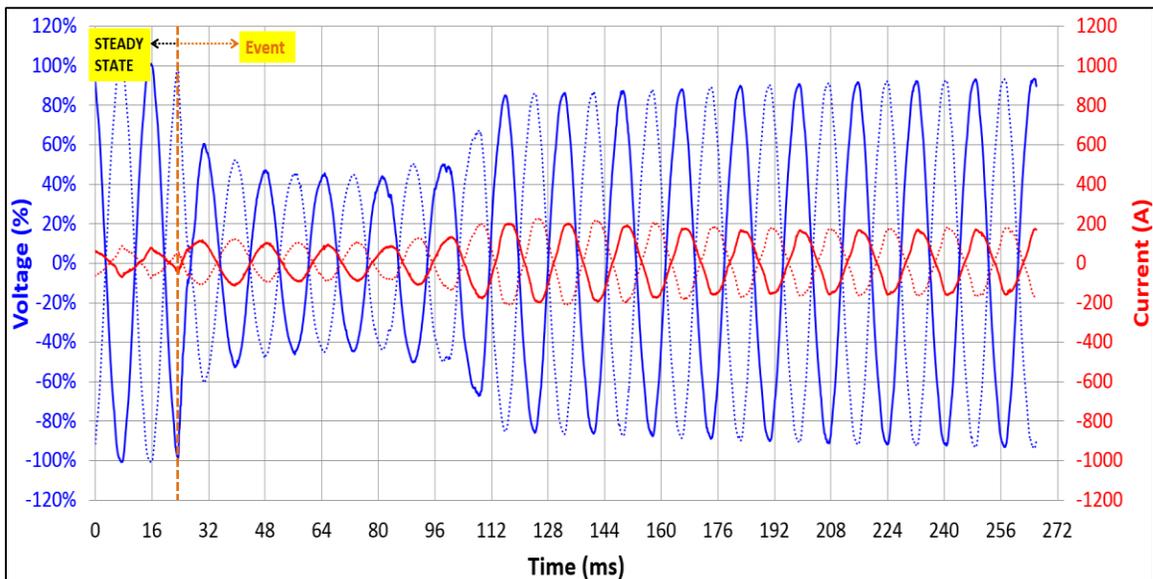
Figure 7.8.2 Event #8 (October 24, 15:34 PDT) Sinusoidal Data [PQ 8]

The sinusoidal waveform data from the PQ 8 device indicates that the fault occurred at the 80 degree angle of the Line 2 voltage waveform. The current is nearly 75 amps-peak before the event and as high as 220 amps-peak within the window of the sinusoidal data captured.
