CERTS Microgrid Tecogen InVerde INV100 Test Report

3/5/2012

D. Klapp, R. Zimmerly, J. Howard
AEP Dolan Technology Center
Groveport, OH

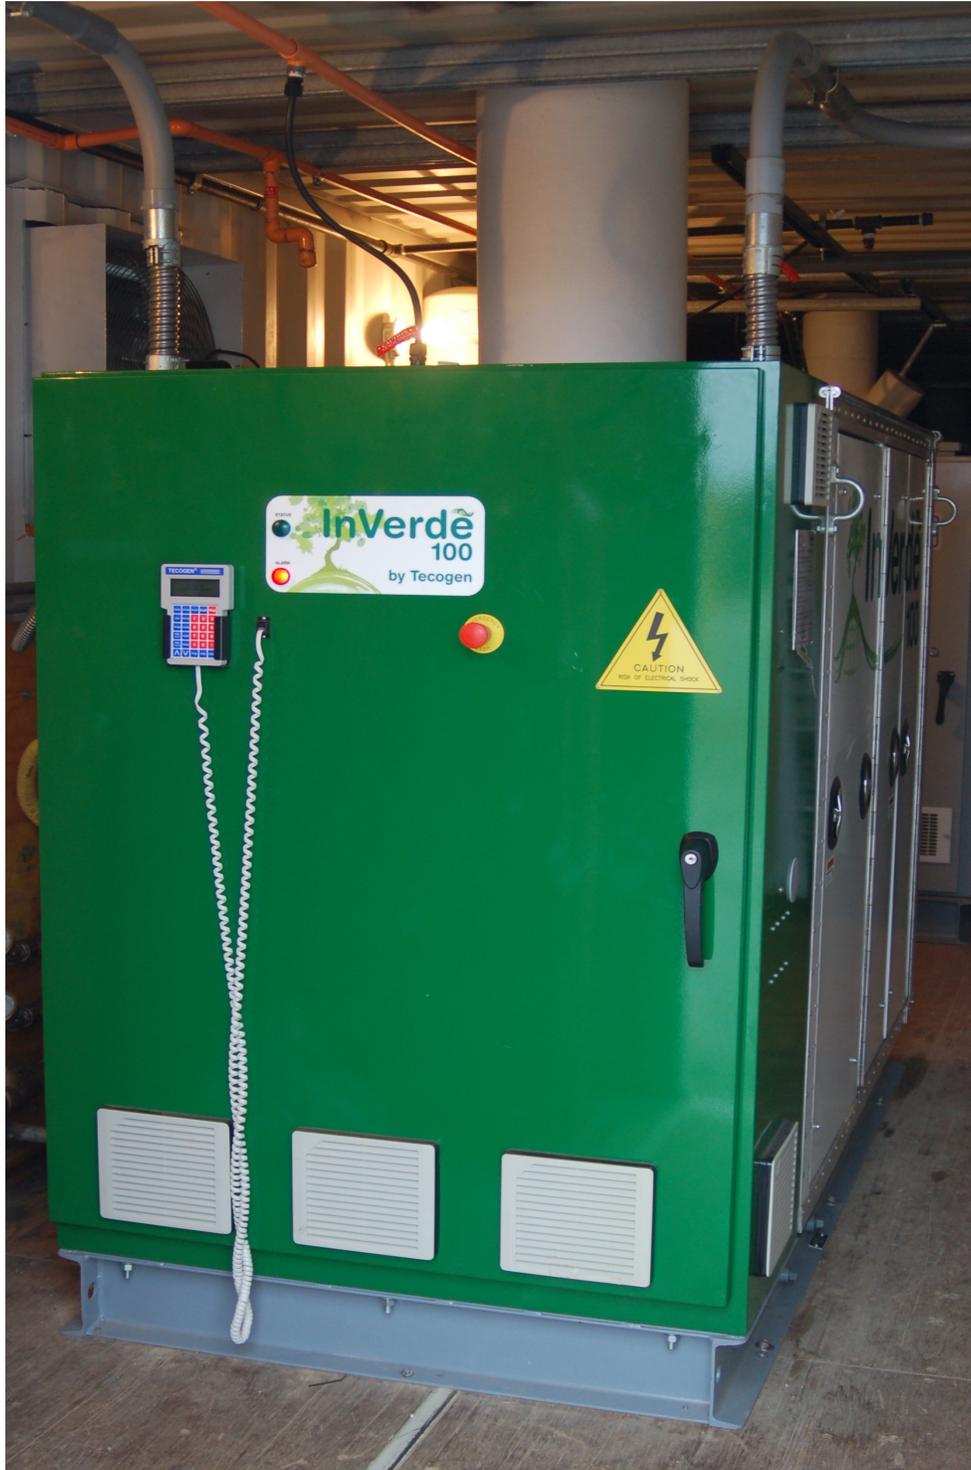
Figure 1 - Front view of the InVerde INV100 inside the genset enclosure

Figures 1-4 display the InVerde INV100 100 installation in the test bed.

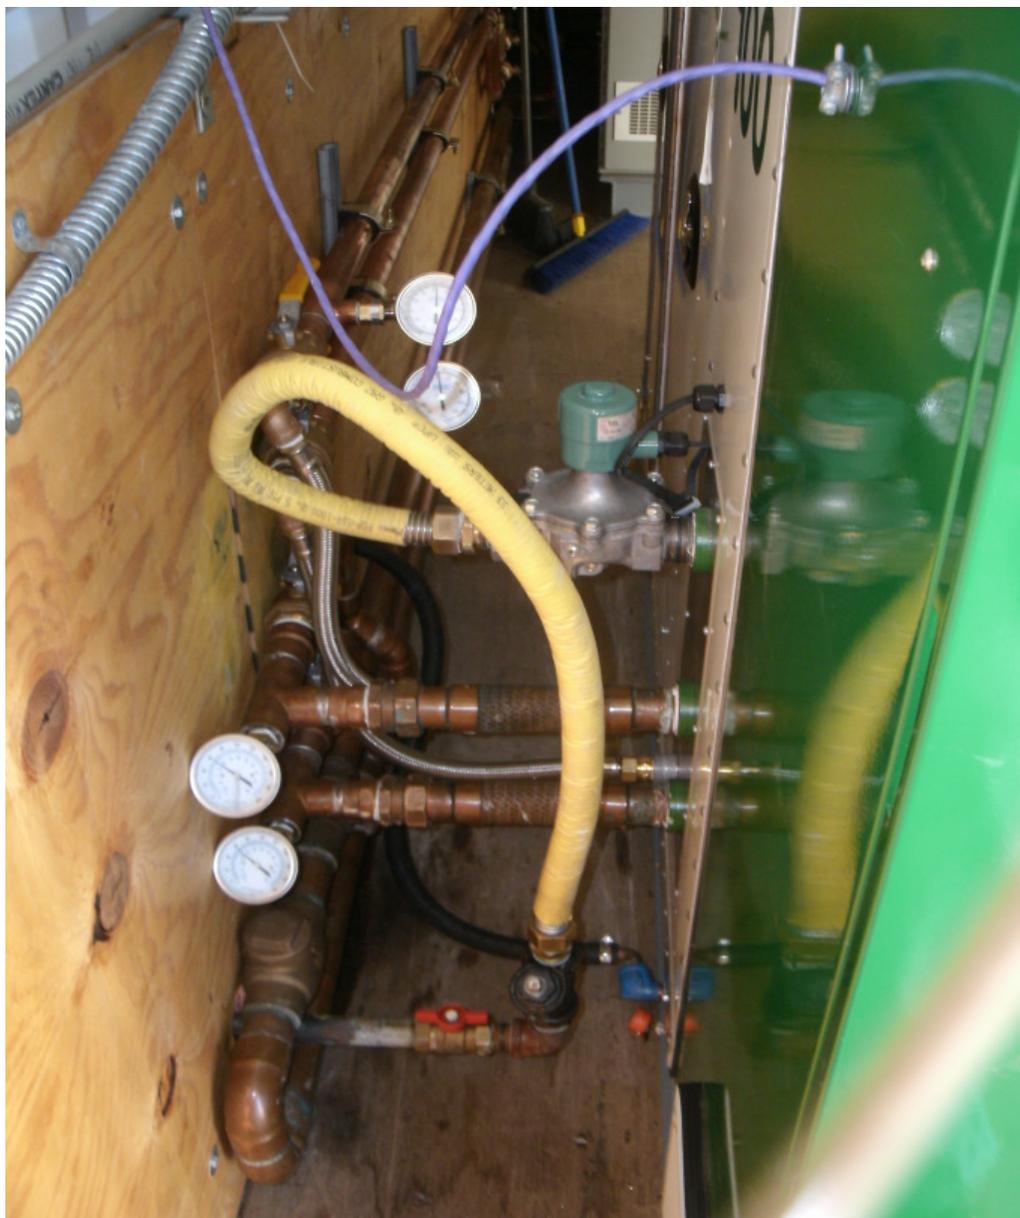
Figure 2 - Natural gas, water, and network connections to the InVerde INV100

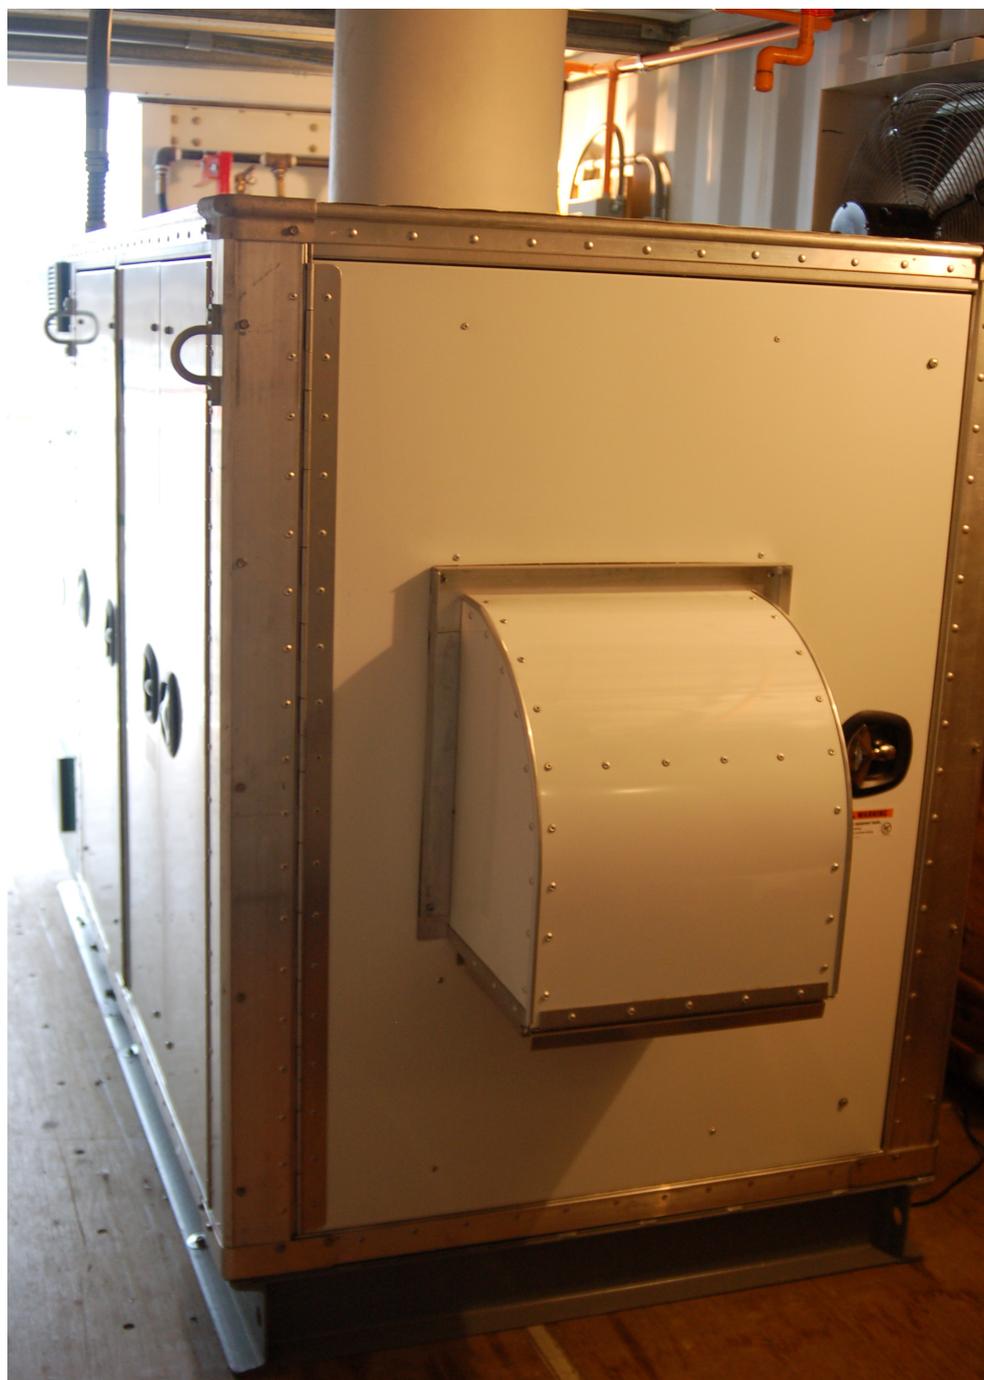
Figure 3 – Rear view of the InVerde INV100 inside the genset enclosure
