INTERIM REPORT OF THE U.S. DEPARTMENT OF ENERGY'S POWER OUTAGE STUDY TEAM

FINDINGS FROM THE SUMMER OF 1999

JANUARY 2000

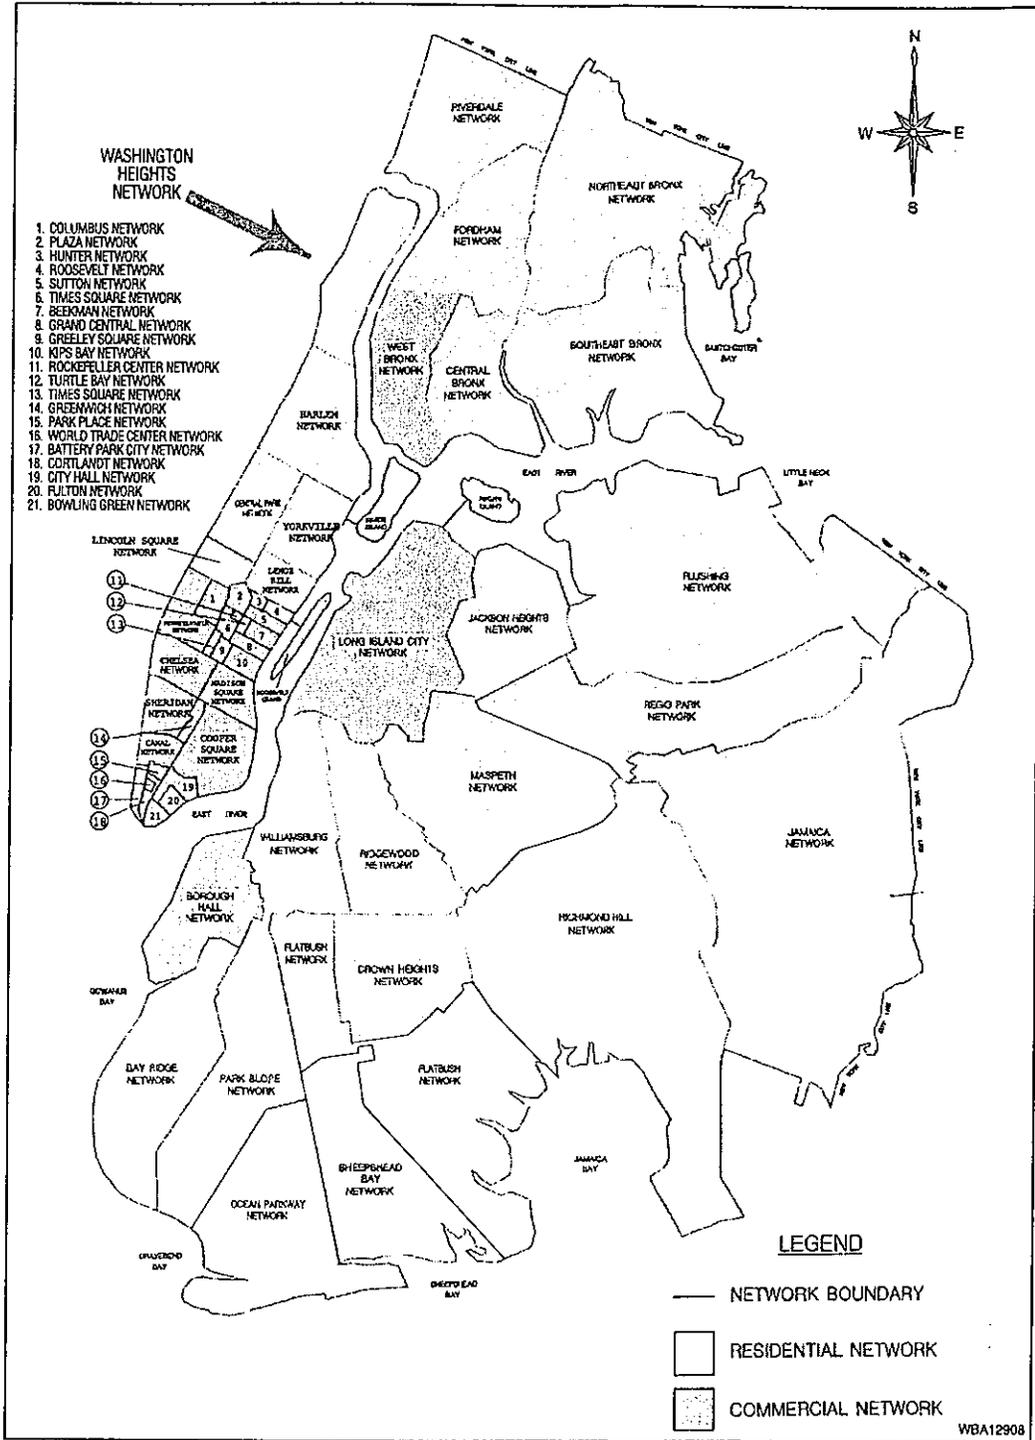
Figure 1 New York City: Map of Consolidated Edison Electric Distribution Network System

Consolidated Edison Company (Con Ed) is a member of the NYPP and the NPCC. Con Ed serves the most dense electrical *load pocket* in the world. It has more than 3.1 million customers in an area of 604 square miles served by more than 90,000 miles of underground distribution cable and 255,000 manholes and service boxes. Con Ed uses a *distribution network* concept. The networks are low-voltage grids supplied by 13.8-kilovolt (kV) feeders that cover anywhere from several city blocks to several square miles. The networks are mostly underground, beneath the streets and sidewalks. The Con Ed system includes about 25 distribution networks within the city limits. Each network is independent from its neighboring networks and is fed from multiple distribution feeders. Con Ed has 50% of all the distribution networks in the world, and its engineers are experts who often act as consultants for other distribution networks. Figure 1 is a map of the Con Ed network system.

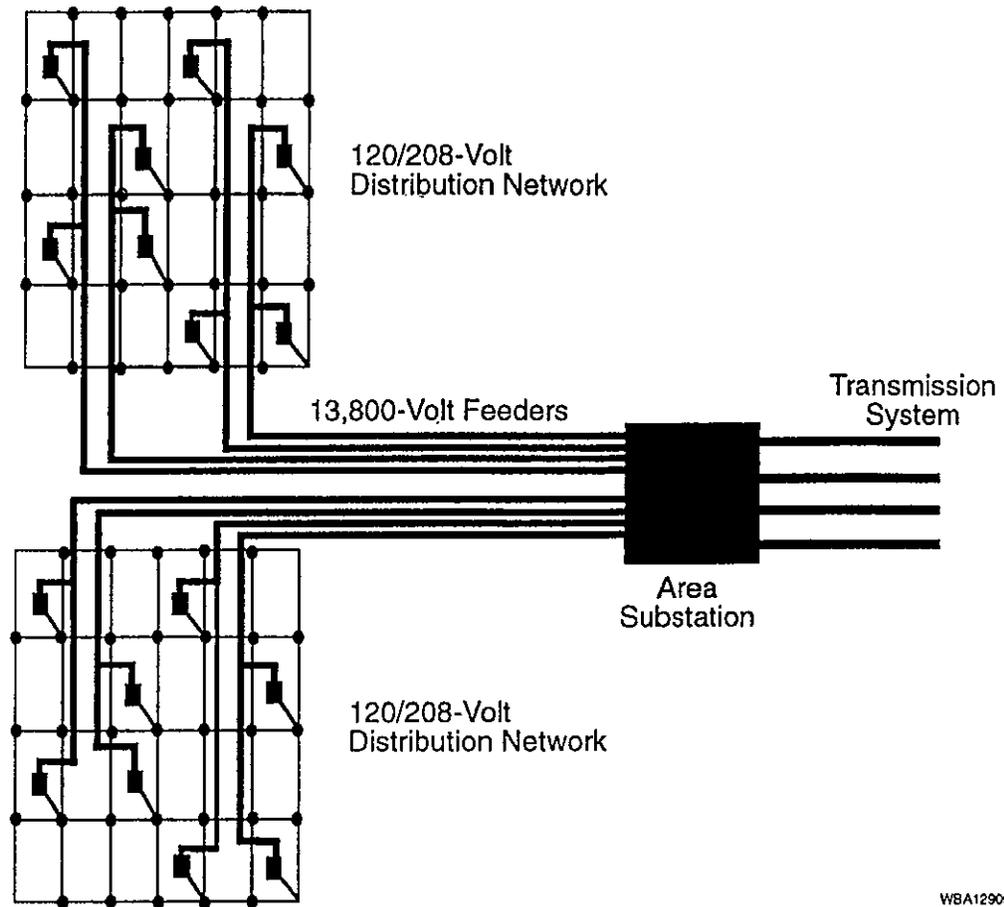
Figure 2 New York City: Consolidated Edison Distribution Network

The basic design of the network system provides for overall high reliability. However, when large numbers of feeders fail simultaneously, an entire network might have to be de-energized. The low-voltage distribution network consists of an underground grid of interconnected low-voltage conductors – essentially a mesh of interconnected wires (Figure 2). The low-voltage conductors are protected by *current limiters*.

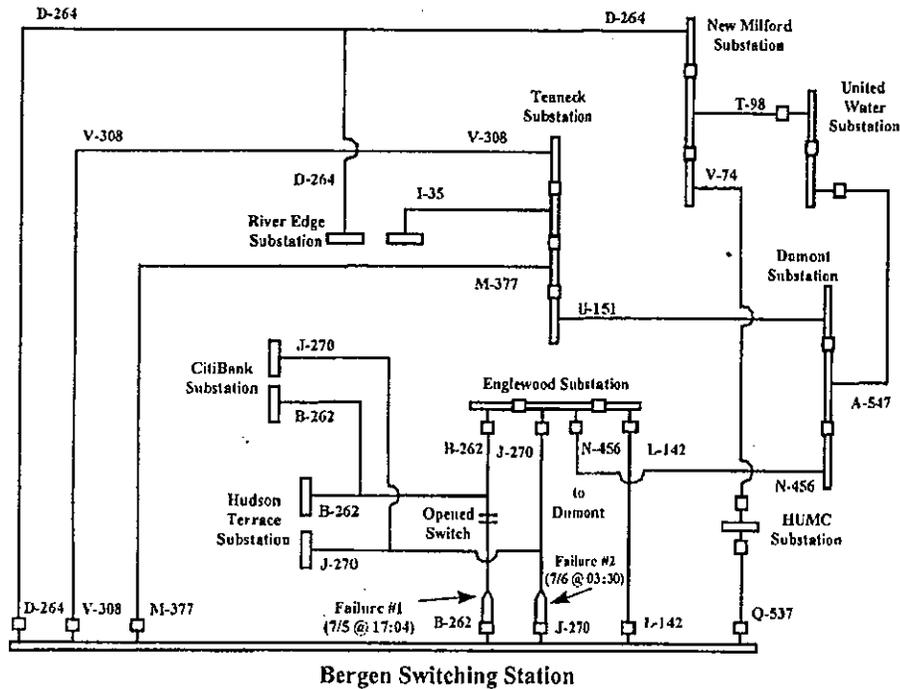
Figure 6 New Jersey: Public Service Electric and Gas Company Interconnections to Bergen Switching Station

This section describes the series of equipment failures that occurred at the Englewood, Hudson Terrace, and CitiBank substations and within the 26-kV Bergen County loop. Interconnections among these substations are shown in Figure 6. At 5:04 p.m. on July 5, 1999, a terminator fault on a 26-kV riser pole tripped circuit B-262,

which feeds the Englewood, Hudson Terrace, and CitiBank substations from the Bergen switching station.

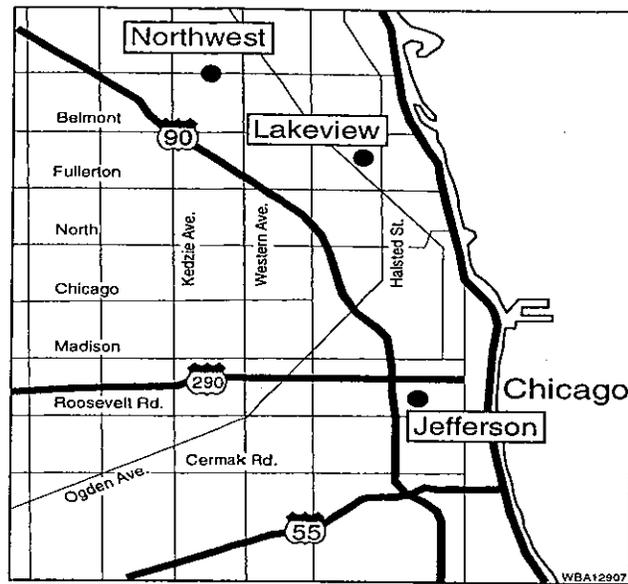
Figure 7 Chicago: Map Showing Locations of Commonwealth Edison's Northwest, Lakeview, and Jefferson Substations

In the summer of 1999, three major outages occurred in ComEd's service territory. These events, which took place from July 20 through August 12, centered around three of ComEd's substations in Chicago: Northwest substation, Lakeview substation, and Jefferson substation (Figure 7). Although the voltage levels of equipment directly affected measured as high as 69 kV, with indirect effects at the 138-kV level, the three outages clearly resulted from problems with the *distribution system*.

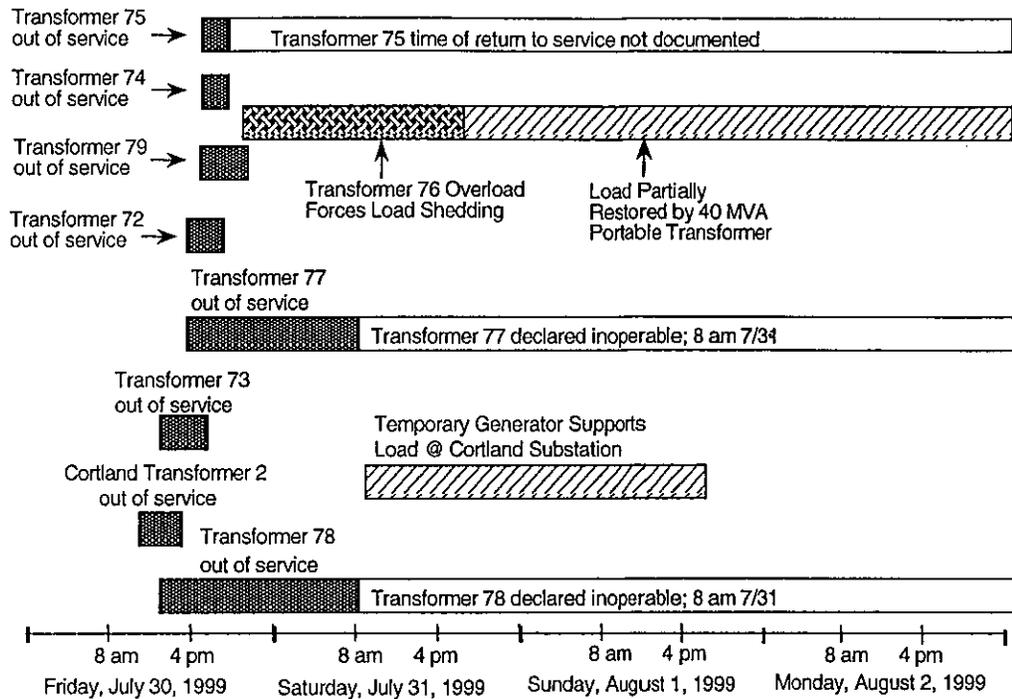
Figure 9 Chicago: Event Timeline for Commonwealth Edison's Northwest Substation

A timeline for these events is provided in Figure 9. The general pattern shows initial cable faults occurring under high load conditions, transformers being removed from service, and *cascading* transformer overloads. A comparison of Figures 8 and 9 shows a close correlation between the periods when transformers were out of service and the periods when many customers were without power.
