**U.S.-Canada Power System Outage Task Force**

**Interim Report:  
Causes of the  
August 14th Blackout  
in the  
United States and Canada**

**November 2003**

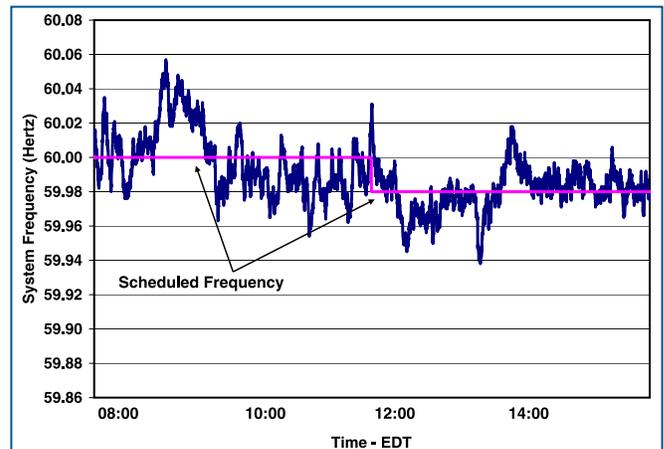
**Figure 3.4. Frequency on August 14, 2003, up to 15:31 EDT**

a principal means by which the blackout spread across a wide area (Figure 3.4).

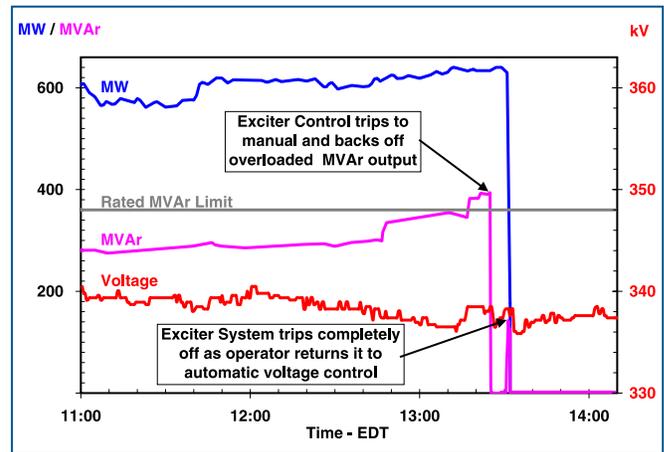
**Figure 3.5. MW and MVar Output from Eastlake Unit 5 on August 14**

output (Figure 3.5), the unit's protection system detected a failure and tripped the unit off-line. The loss of the Eastlake 5 unit did not put the grid into an unreliable state—i.e., it was still able to withstand safely another contingency. However, the loss of the unit required FE to import additional power to make up for the loss of the unit's output (540 MW), made voltage management in northern Ohio more challenging, and gave FE operators less flexibility in operating their system (see details below, page 27).

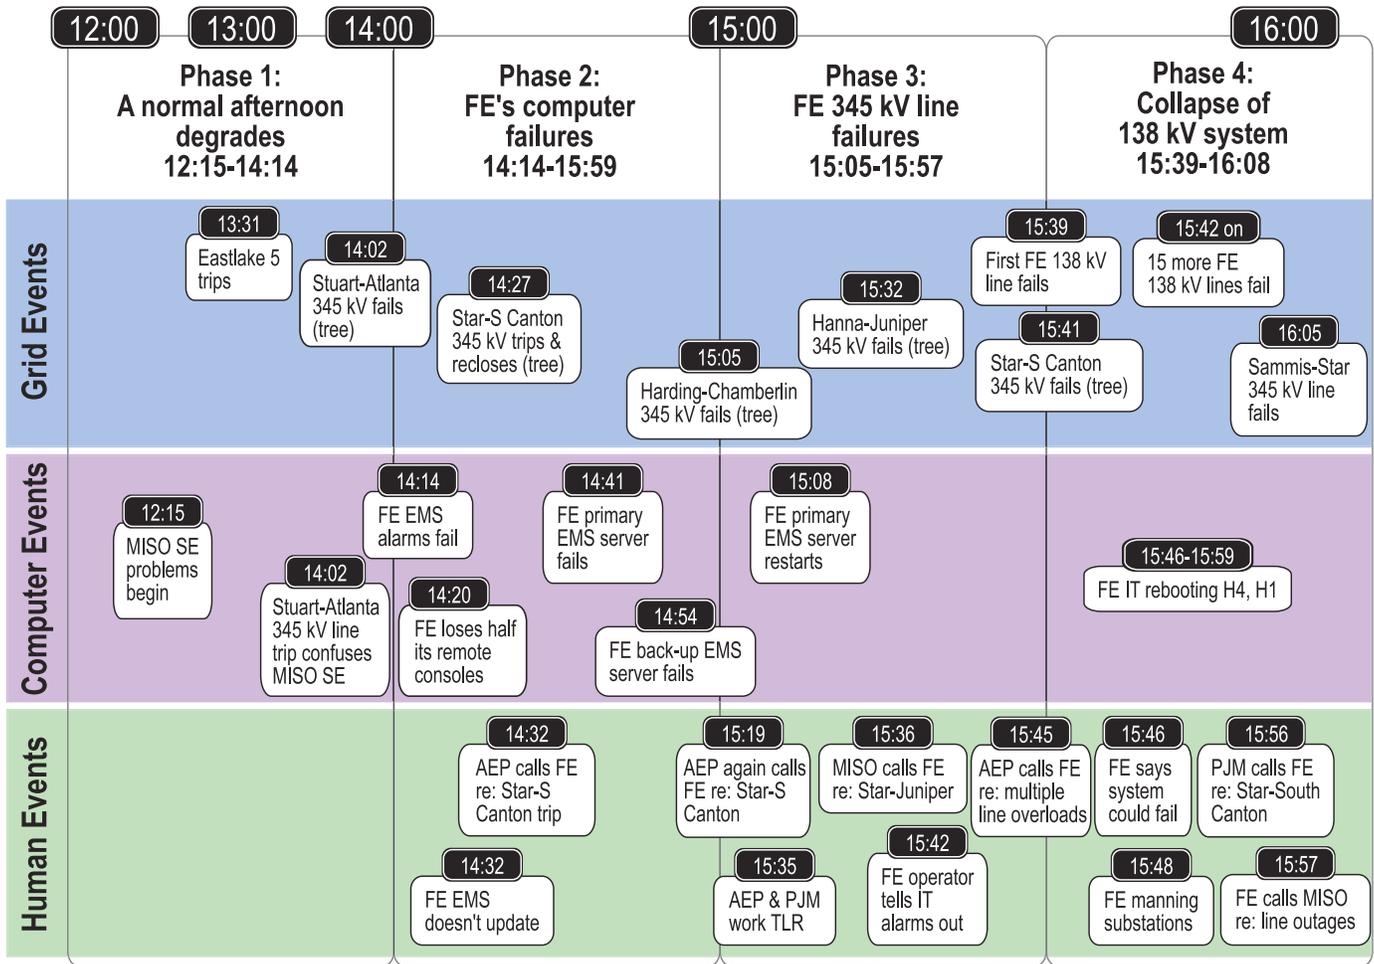
**Figure 4.1. Timeline: Start of the Blackout in Ohio**

Key events within each phase are summarized in Figure 4.1, a timeline of major events in the origin of the blackout in Ohio. The discussion that follows highlights and explains these significant events within each phase and explains how the events were related to one another and to the cascade.

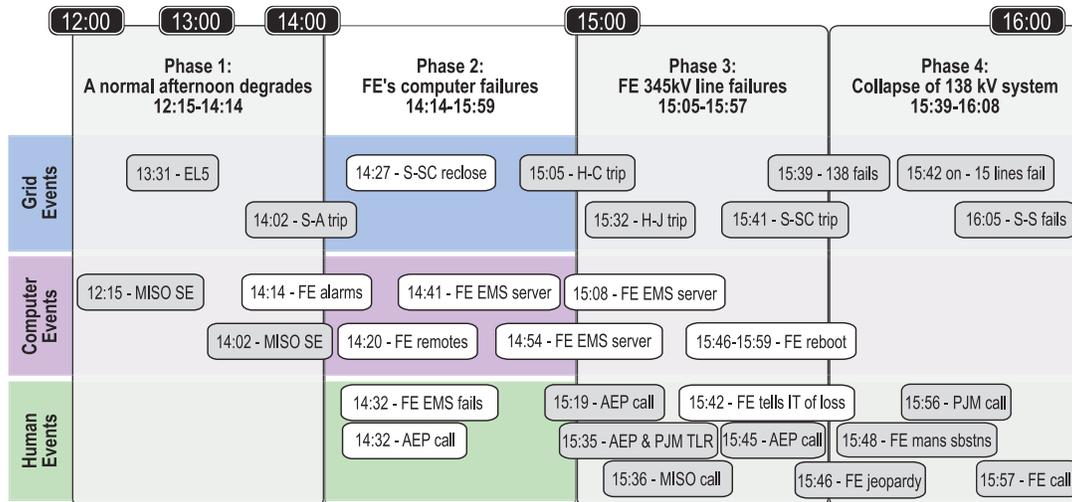
Figure 4.4. Timeline Phase 2

- 2A) 14:14 EDT: FE alarm and logging software failed. Neither FE's control room operators nor FE's IT EMS support personnel were aware of the alarm failure.
- 2B) 14:20 EDT: Several FE remote location consoles failed. FE Information Technology (IT) engineer was computer auto-paged.
- 2C) 14:27:16 EDT: Star-South Canton 345-kV transmission line tripped and successfully reclosed.
- 2D) 14:32 EDT: AEP called FE control room about AEP indication of Star-South Canton 345-kV line trip and reclosure. FE had no alarm or log of this line trip.
- 2E) 14:41 EDT: The primary FE control system server hosting the alarm function failed. Its applications and functions were passed over to a backup computer. FE's IT engineer was auto-paged.

2F) 14:54 EDT: The FE back-up computer failed and all functions that were running on it stopped. FE’s IT engineer was auto-paged.

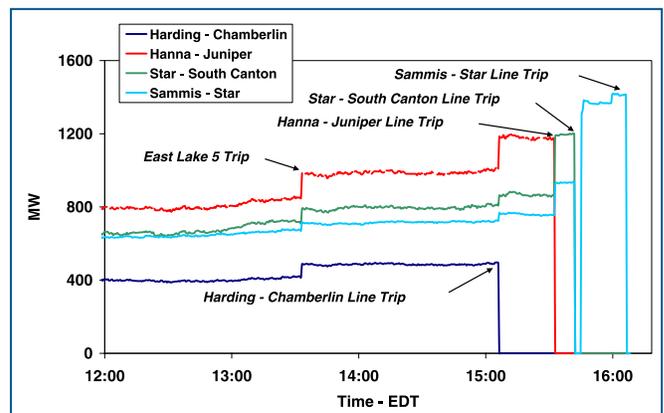
Figure 4.5. FirstEnergy 345-kV Line Flows

From 15:05:41 EDT to 15:41:35 EDT, three 345-kV lines failed with power flows at or below each transmission line's emergency rating. Each was the result of a contact between a line and a tree that had grown so tall that, over a period of years, it encroached into the required clearance height for the line. As each line failed, its outage increased the loading on the remaining lines (Figure 4.5). As each of the transmission lines failed, and power flows shifted to other transmission paths, voltages on the rest of FE's system degraded further (Figure 4.6).

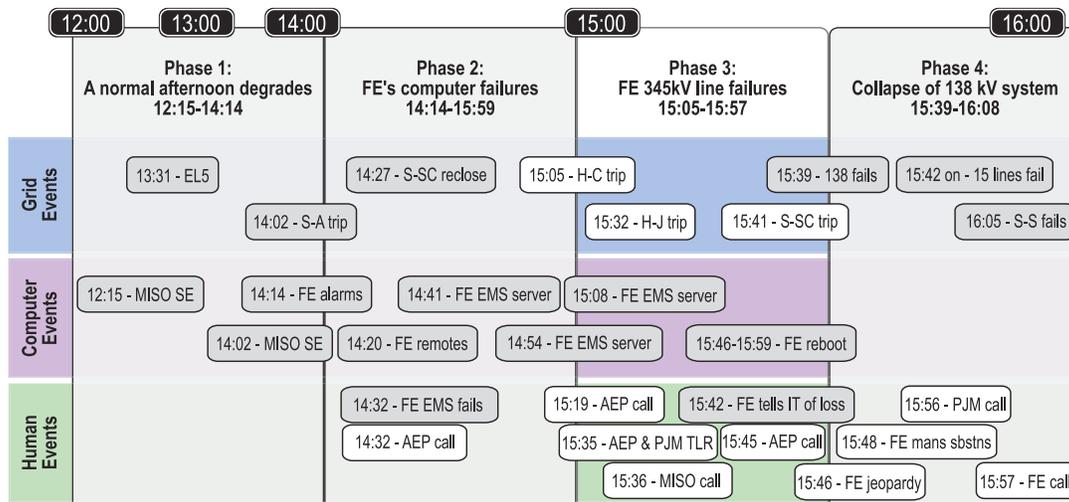
**Figure 4.7. Timeline Phase 3**

- 3A) 15:05:41 EDT: Harding-Chamberlin 345-kV line tripped.
- 3B) 15:31-33 EDT: MISO called PJM to determine if PJM had seen the Stuart-Atlanta 345-kV line outage. PJM confirmed Stuart-Atlanta was out.

- 3C) 15:32:03 EDT: Hanna-Juniper 345-kV line tripped.
- 3D) 15:35 EDT: AEP asked PJM to begin work on a 350-MW TLR to relieve overloading on the Star-South Canton line, not knowing the Hanna-Juniper 345-kV line had already tripped at 15:32 EDT.
- 3E) 15:36 EDT: MISO called FE regarding post-contingency overload on Star-Juniper 345-kV line for the contingency loss of the Hanna-Juniper 345-kV line, unaware at the start of the call that Hanna-Juniper had already tripped.
- 3F) 15:41:33-41 EDT: Star-South Canton 345-kV tripped, reclosed, tripped again at 15:41 EDT and remained out of service, all while AEP and PJM were discussing TLR relief options (event 3D).

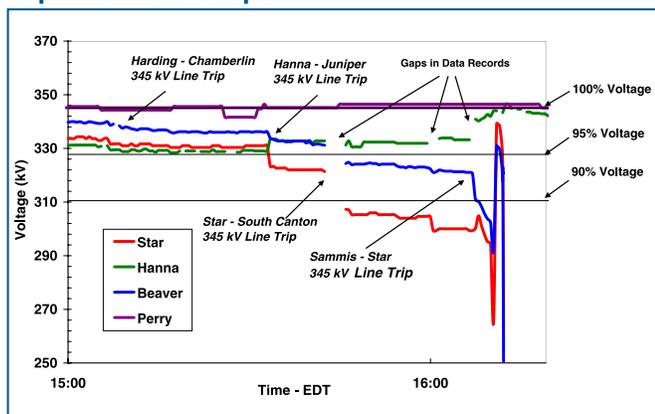
**Figure 4.6. Voltages on FirstEnergy’s 345-kV Lines: Impacts of Line Trips**

A short-circuit occurred on the Harding-Chamberlin 345-kV line due to a contact between the line conductor and a tree. This line failed with power flow at only 43.5% of its normal and emergency line rating. Incremental line current and temperature increases, escalated by the loss of Harding-Chamberlin, caused enough sag on the Hanna-Juniper line that it contacted a tree and faulted with power flow at 87.5% of its normal and emergency line rating. Star-South Canton contacted a tree three times between 14:27:15 EDT and 15:41:33 EDT, opening and reclosing each time before finally locking out while loaded at 93.2% of its emergency rating at 15:42:35 EDT.

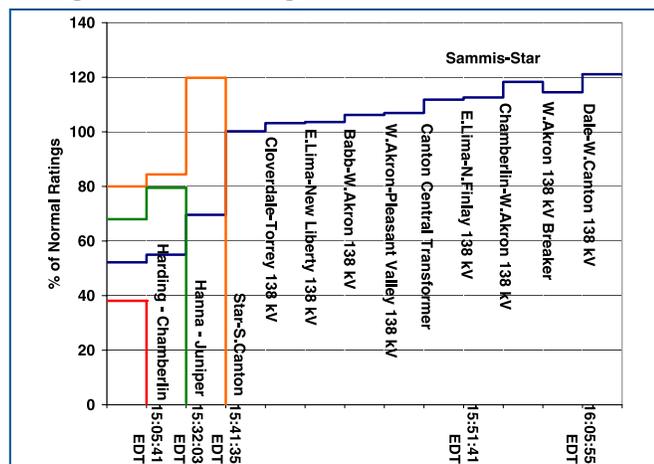
**Figure 4.12. Cumulative Effects of Sequential Outages on Remaining 345-kV Lines**

According to extensive investigation team modeling, there were no contingency limit violations as of 15:05 EDT prior to the loss of the Chamberlin-Harding 345-kV line. Figure 4.12 shows the line loadings estimated by investigation team modeling as the 345-kV lines in northeast Ohio began to trip. Showing line loadings on the 345-kV lines as a percent of normal rating, it tracks how the loading on each line increased as each subsequent 345-kV and 138-kV line tripped out of service between 15:05 EDT (Harding-Chamberlin, the first line above to stair-step down) and 16:06 EDT (Dale-West Canton). As the graph shows, none of the 345- or 138-kV lines exceeded their normal ratings until after the combined trips of Harding-Chamberlin and Hanna-Juniper. But immediately after the second line was lost, Star-South Canton's loading jumped from an estimated 82% of normal to 120% of normal (which was still below its emergency rating) and remained at the 120% level for 10 minutes before tripping out. To the right, the graph shows the effects of the 138-kV line failures (discussed in the next phase) upon the two remaining 345-kV lines—i.e., Sammis-Star's loading increased steadily above 100% with each succeeding 138-kV line lost.

- ◆ The Star-Juniper 345-kV line, whose loadings would exceed emergency limits if the Hanna-Juniper 345-kV line were lost; and
- ◆ The Hanna-Juniper and Harding-Juniper 345-kV lines, whose loadings would exceed emergency limits if the Perry generation unit (1,255 MW) were lost.

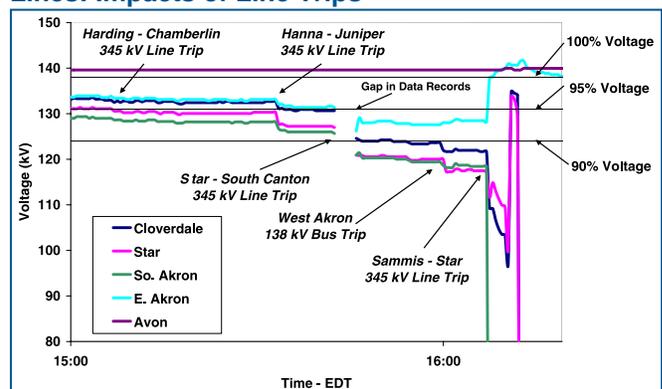
**Figure 4.14. Voltages on FirstEnergy’s 138-kV Lines: Impacts of Line Trips**

As each of FE’s 345-kV lines in the Cleveland area tripped out, it increased loading and decreased voltage on the underlying 138-kV system serving Cleveland and Akron, pushing those lines into overload. Starting at 15:39 EDT, the first of an eventual sixteen 138-kV lines began to fail. Figure 4.14 shows how actual voltages declined at key 138-kV buses as the 345- and 138-kV lines were lost. As these lines failed, the voltage drops caused a number of large industrial customers with voltage-sensitive equipment to go off-line automatically to protect their operations. As the 138-kV lines opened, they blacked out customers in

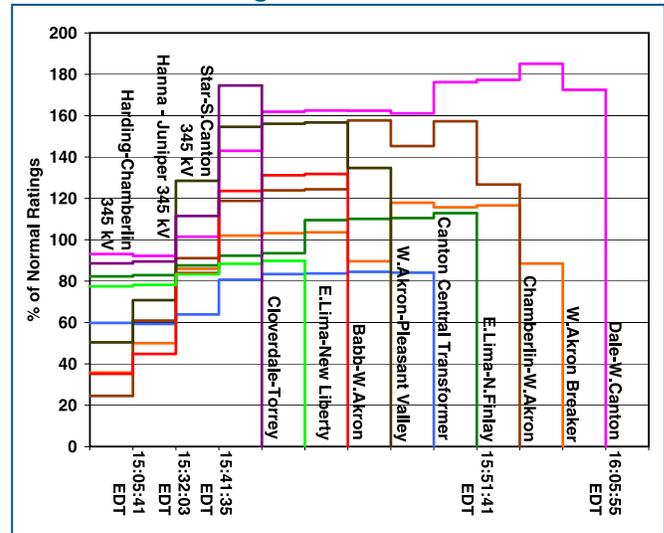
**Figure 4.15. Simulated Effect of Prior Outages on 138-kV Line Loadings**

FE's 345- and key 138-kV northeast Ohio lines as the line failures progressed. All lines were loaded within normal limits after the Harding-Chamberlin lock-out, but after the Hanna-Juniper trip at 15:32, the Star-South Canton 345-kV line and three 138-kV lines jumped above normal loadings. After Star-South Canton locked out at 15:41 EDT, five 138-kV and the Sammis-Star 345-kV lines were overloaded and Star-South Canton was within its emergency rating. From that point, as the graph shows, each subsequent line loss increased loadings on other lines, some loading to well over 150% of normal ratings before they failed. The Sammis-Star 345-kV line stayed in service until it tripped at 16:05:57 EDT.

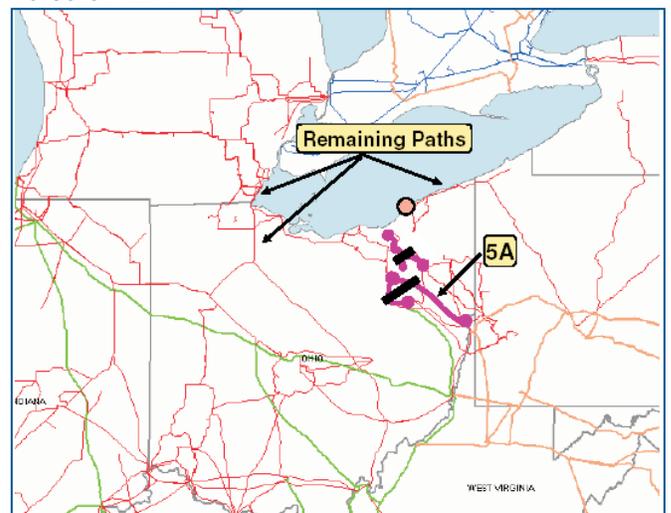
**Figure 5.2. Sammis-Star 345-kV Line Trip, 16:05:57 EDT**

This initial phase of the cascade began because after the loss of FE's Sammis-Star 345-kV line and the underlying 138-kV system, there were no large transmission paths left from the south to support the significant amount of load in northern Ohio (Figure 5.2). This placed a significant load burden

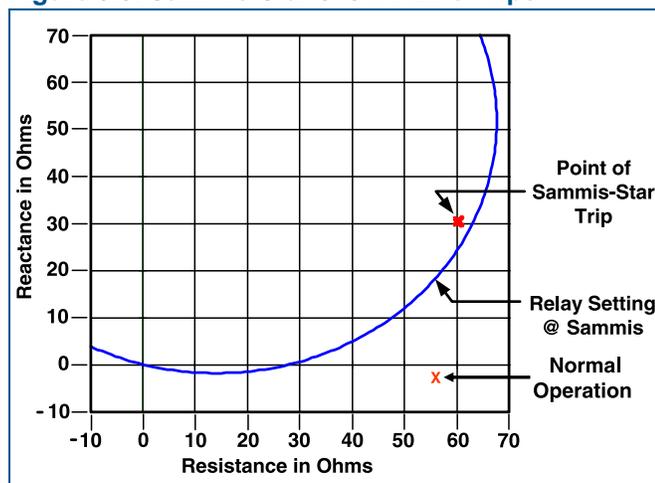
Figure 5.3. Sammis-Star 345-kV Line Trips

Sammis-Star did not trip due to a short circuit to ground (as did the prior 345-kV lines that tripped). Sammis-Star tripped due to protective relay action that measured low apparent impedance (depressed voltage divided by abnormally high line current) (Figure 5.3). There was no fault and no major power swing at the time of the trip—rather, high flows above the line’s emergency rating together with depressed voltages caused the overload to appear to the protective relays as a remote fault on the system. In effect, the relay could no longer differentiate between a remote three-phase fault and an exceptionally high line-load condition. Moreover, the reactive flows (VARs) on the line were almost ten times higher than they had been earlier in the day. The relay operated as it was designed to do.

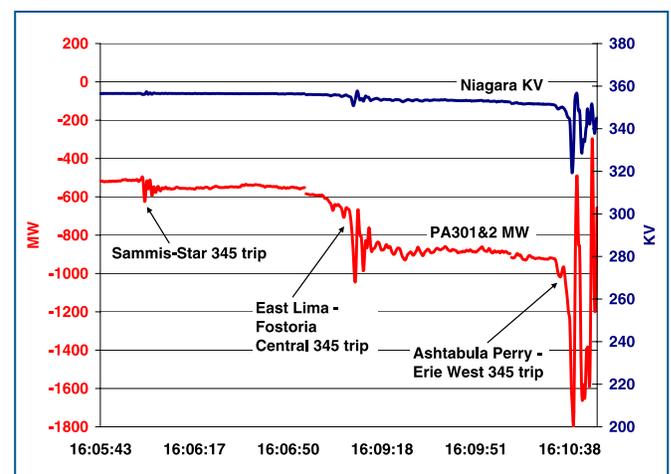
**Figure 5.5. New York-Ontario Line Flows at Niagara**

In Figure 5.5, a high-speed recording of 345-kV flows past Niagara Falls shows the New York to Ontario power swing, which continued to oscillate for over 10 seconds. The recording shows the magnitude of subsequent flows triggered by the trips of the Hampton-Pontiac and Thetford-Jewell 345-kV lines in Michigan and the Perry-Ashtabula 345-kV line linking the Cleveland area to Pennsylvania. The very low voltages on the northern Ohio transmission system made it very difficult for the generation in the Cleveland and Lake Erie area to maintain synchronization with the Eastern Interconnection. Over the next two minutes, generators in this area shut down after reaching a point of no

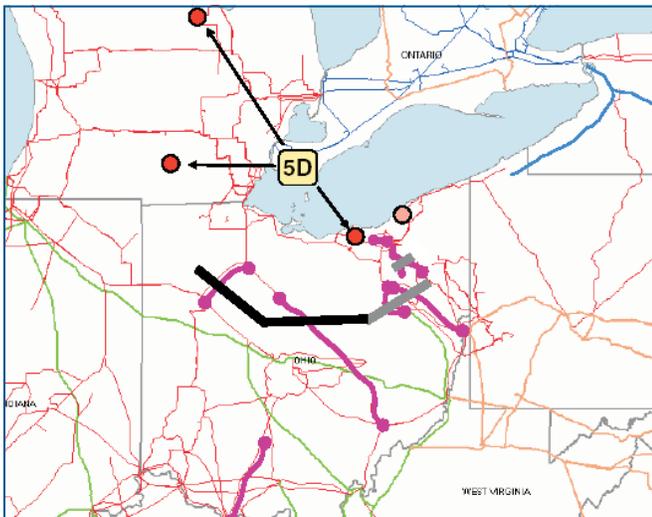
**Figure 5.6. Michigan and Ohio Power Plants Trip**

The Midland Cogeneration Venture (MCV) plant is in central Michigan. Kinder Morgan is in south-central Michigan. The large power reversal caused frequency and voltage fluctuations at the plants. Their automatic control systems responded to these transients by trying to adjust output to raise voltage or respond to the frequency changes, but subsequently tripped off-line. The Avon Lake and Burger units, in or near Cleveland, likely tripped off due to the low voltages prevailing in the Cleveland area and 138-kV line trips near Burger 138-kV substation (northern Ohio) (Figure 5.6).

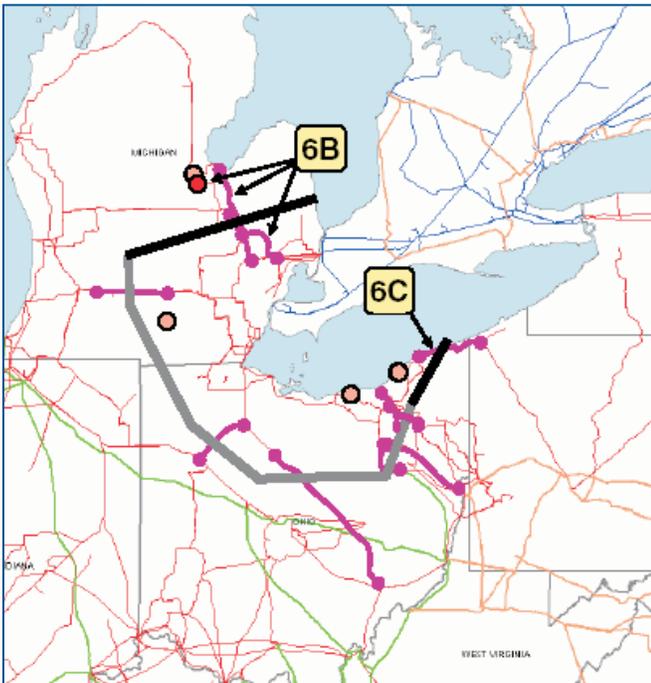
**Figure 5.8. Michigan Lines Trip and Ohio Separates from Pennsylvania, 16:10:36 to 16:10:38.6 EDT**

Michigan and Ontario systems (Figure 5.8). Eastern Michigan and northern Ohio now had little internal generation left and voltage was declining. Between 16:10:39 EDT and 16:10:50 EDT under-frequency load shedding in the Cleveland area operated and interrupted about 1,750 MW of load. The frequency in the Cleveland area (by then separated from the Eastern Interconnection to the south) was also dropping rapidly and the load shedding was not enough to arrest the frequency decline. Since the electrical system always seeks to balance load and generation, the high loads in Cleveland drew power over the only major transmission path remaining—the lines from eastern Michigan east into Ontario.

This was a transient frequency swing, so frequency was not the same across the Eastern Interconnection. As Figure 5.8 shows, this frequency imbalance and the accompanying power swing resulted in a rapid rate of voltage decay. Flows into Detroit exceeded 3,500 MW and 1,500 MVAR, meaning that the power surge was draining both active and reactive power out of the northeast to prop up the low voltages in eastern Michigan and Detroit. This magnitude of reactive power draw caused voltages in Ontario and New York to drop. At the same time, local voltages in the Detroit area were low because there was still not enough supply to meet load. Detroit would soon black out (as evidenced by the rapid power swings decaying after 16:10:43 EDT).

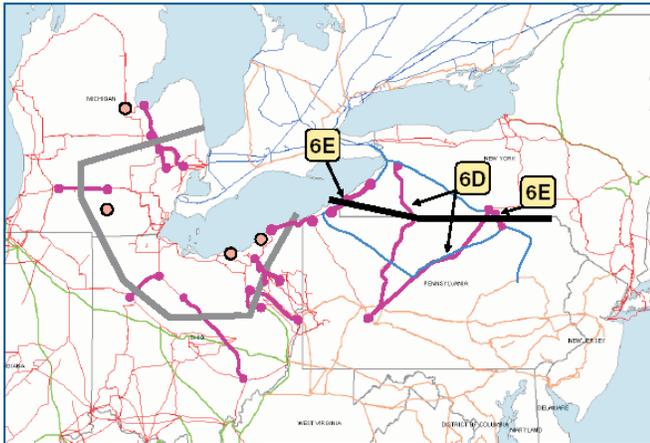
**Figure 5.10. Western Pennsylvania Separates from New York, 16:10:39 EDT to 16:10:44 EDT**

Responding to the surge of power flowing north out of Pennsylvania through New York and Ontario into Michigan, relays on these lines activated on apparent impedance within a five-second period and separated Pennsylvania from New York (Figure 5.10).

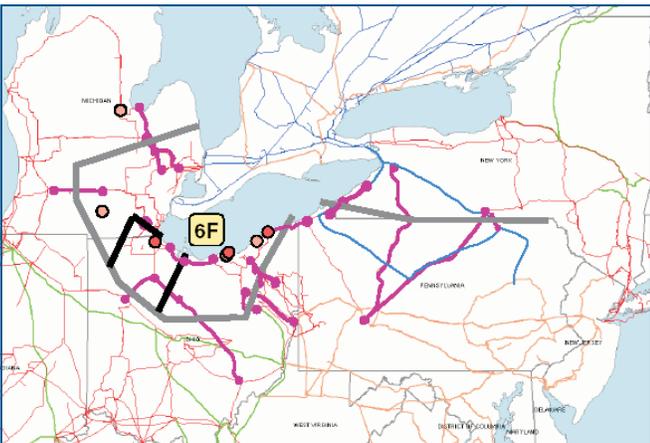
**Figure 5.11. More Transmission Line and Power Plant Losses**

Back in northern Ohio, the trips of the Majestic 345-kV substation in southeast Michigan, the Bay Shore-Monroe 345-kV line, and the Ashtabula 345/138-kV transformer created a Toledo and Cleveland electrical "island" (Figure 5.11). Frequency in this large island began to fall rapidly. This led to a series of power plants in the area shutting down due to the operation of under-frequency relays, including the Bay Shore units. When the Beaver-Davis Besse 345-kV line connecting Cleveland and Toledo tripped, it left the Cleveland area completely isolated. Cleveland area load was disconnected by automatic under-frequency load-shedding (approximately 1,300

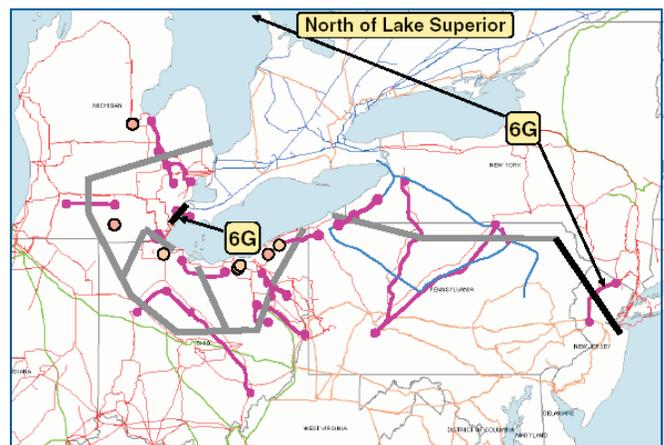
**Figure 5.12. Northeast Disconnects from Eastern Interconnection**

A significant amount of the remaining generation serving Detroit tripped off-line in response to these events. At 16:10:43 EDT, eastern Michigan was still connected to Ontario, but the Keith-Waterman 230-kV line that forms part of that interface disconnected due to apparent impedance (Figure 5.12).

At this point, the Eastern Interconnection was split into two major sections. To the north and east of the separation point lay New York City, northern New Jersey, New York state, New England, the Canadian Maritime provinces, eastern Michigan, the majority of Ontario, and the Québec system. The rest of the Eastern Interconnection, to the south and west of the separation boundary, was not seriously affected by the blackout.

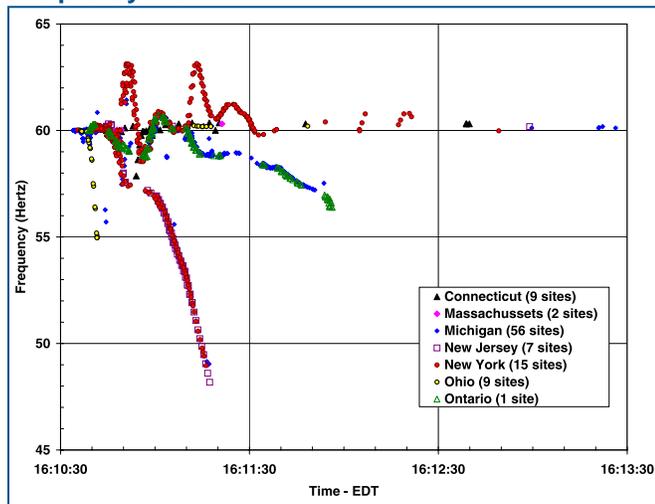
**Figure 5.14. Electric Islands Reflected in Frequency Plot**

**Electrical islanding.** Once the northeast became isolated, it grew generation-deficient as more and more power plants tripped off-line to protect themselves from the growing disturbance. The severe swings in frequency and voltage in the area caused numerous lines to trip, so the isolated area broke further into smaller islands. The load/generation mismatch also affected voltages and frequency within these smaller areas, causing further generator trips and automatic under-frequency load-shedding, leading to blackout in most of these areas.

Figure 5.14 shows frequency data collected by the distribution-level monitors of Softswitching Technologies, Inc. (a commercial power quality company serving industrial customers) for the area affected by the blackout. The data reveal at least five separate electrical islands in the Northeast as the cascade progressed. The two paths of red diamonds on the frequency scale reflect the Albany area island (upper path) versus the New York city island, which declined and blacked out much earlier.

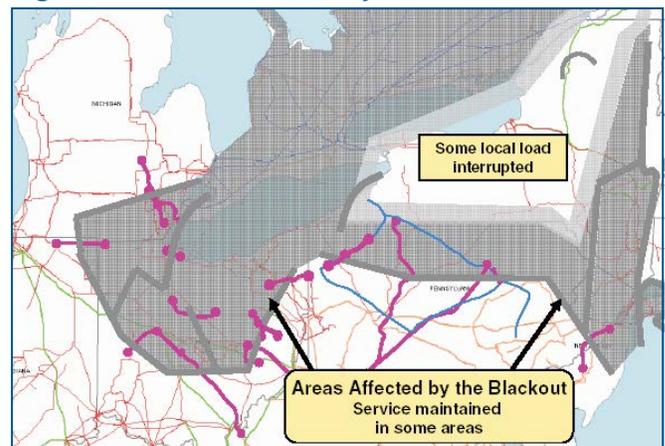
**Figure 5.15. Area Affected by the Blackout**

Most of the Northeast (the area shown in gray in Figure 5.15) was now blacked out. Some isolated areas of generation and load remained on-line for several minutes. Some of those areas in which a close generation-demand balance could be maintained remained operational; other generators ultimately tripped off line and the areas they served were blacked out.

One relatively large island remained in operation serving about 5,700 MW of demand, mostly in western New York. Ontario's large Beck and Saunders hydro stations, along with some Ontario load, the New York Power Authority's (NYPA) Niagara and St. Lawrence hydro stations, and NYPA's 765-kV AC interconnection with Québec, remained connected to the western New York system, supporting demand in upstate New York. This island formed the basis for restoration in both New York and Ontario.

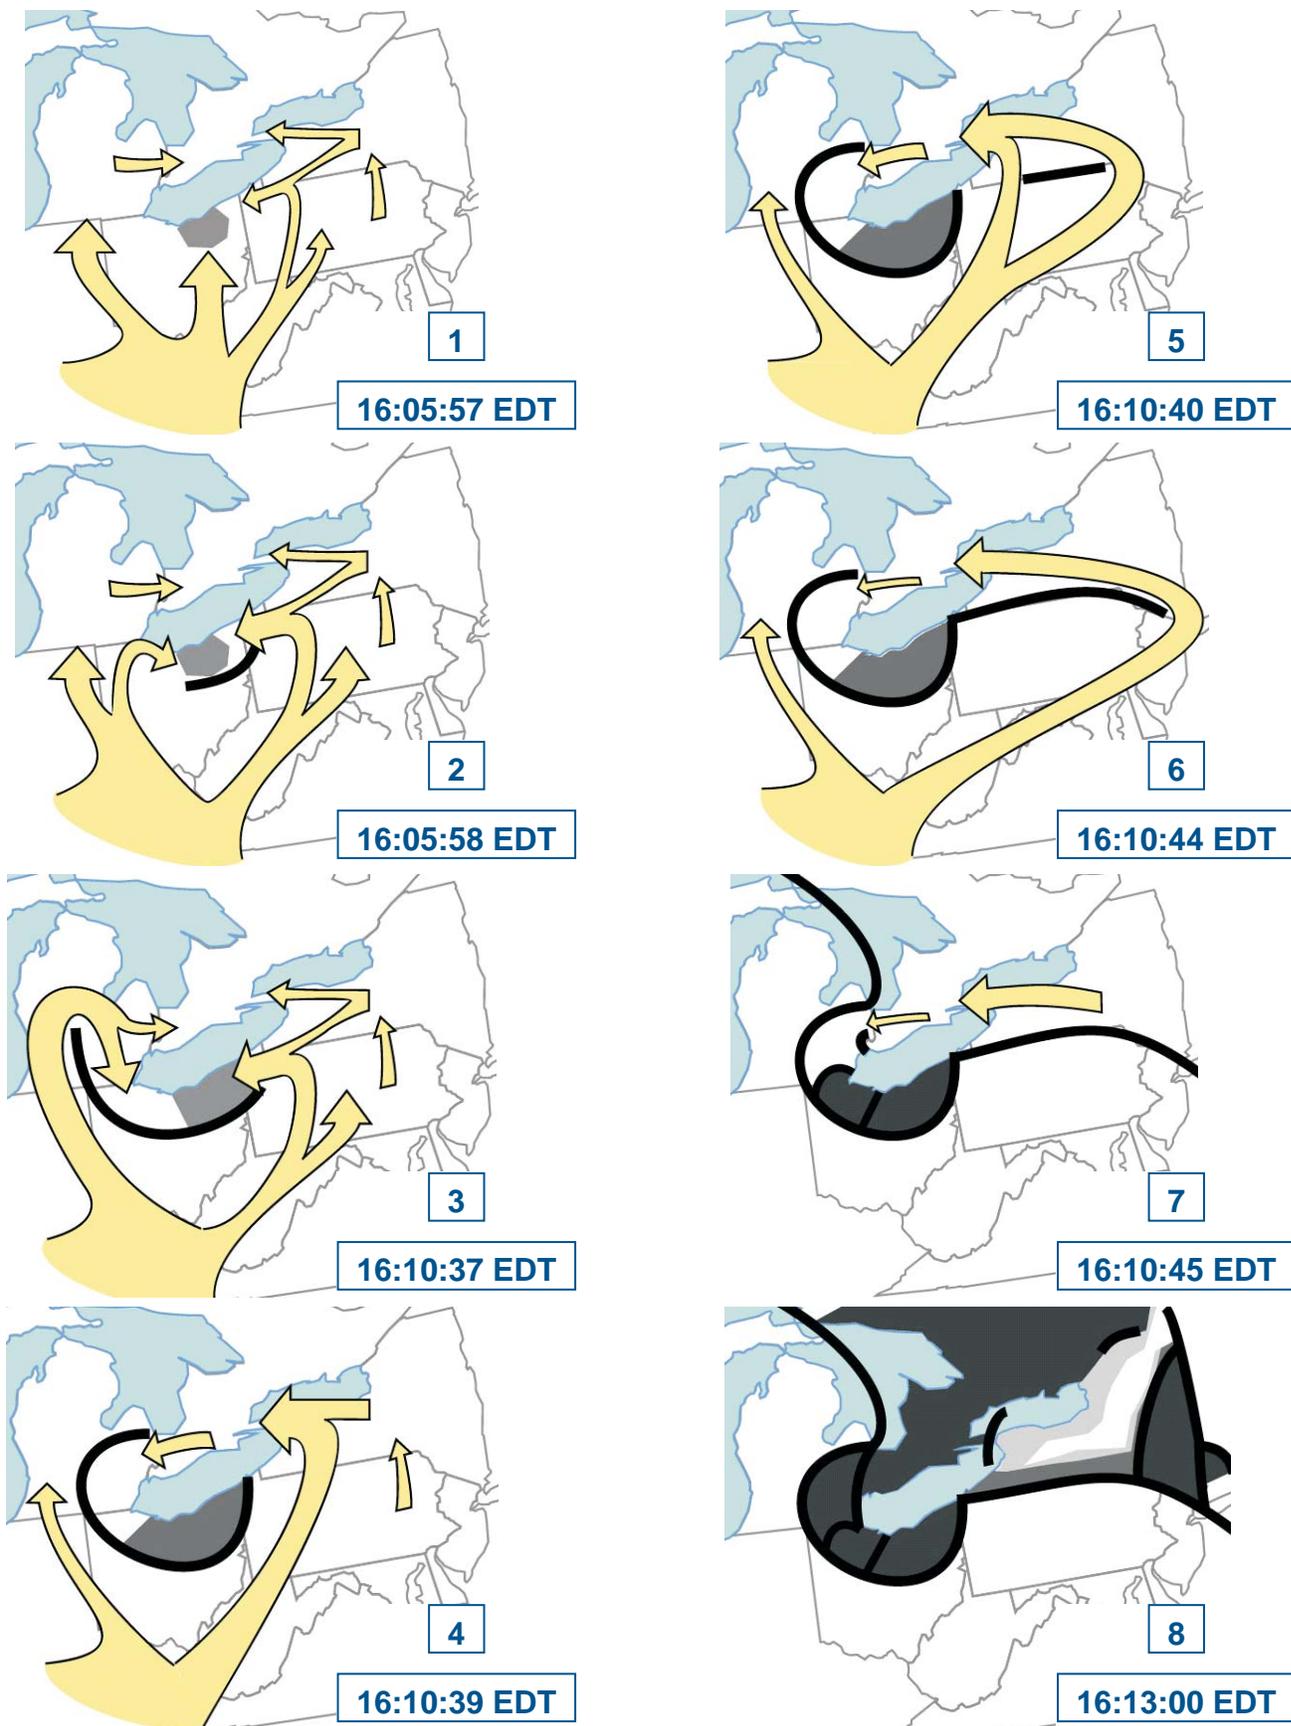
Figure 5.16. Cascade Sequence

The entire cascade sequence is depicted graphically in Figure 5.16 on the following page.

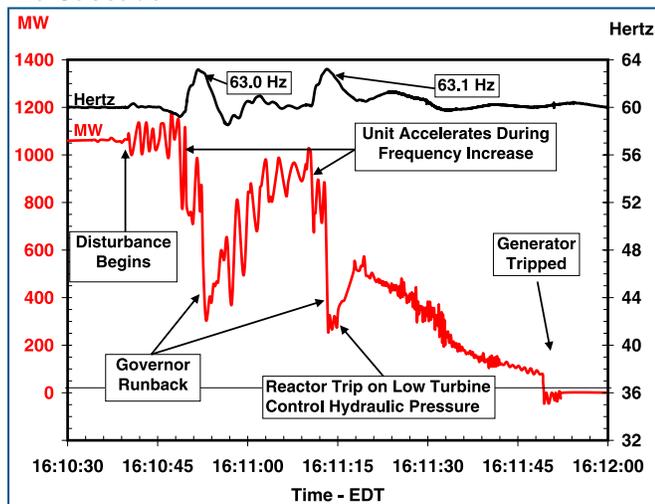
**Figure 5.17. Events at One Large Generator During the Cascade**

After the cascade was initiated, huge power swings across the torn transmission system and excursions of system frequency put all the units in their path through a sequence of major disturbances that shocked several units into tripping. Plant controls had actuated fast governor action on several of these to turn back the throttle, then turn it forward, only to turn it back again as some frequencies changed several times by as much as 3 Hz (about 100 times normal). Figure 5.17 is a plot of the MW output and frequency for one large unit that nearly survived the disruption but tripped when in-plant hydraulic control pressure limits were eventually violated. After the plant control system called for shutdown, the turbine control valves closed and the generator electrical output ramped down to a preset value before the field excitation tripped and the generator breakers opened to disconnect the unit from the system.

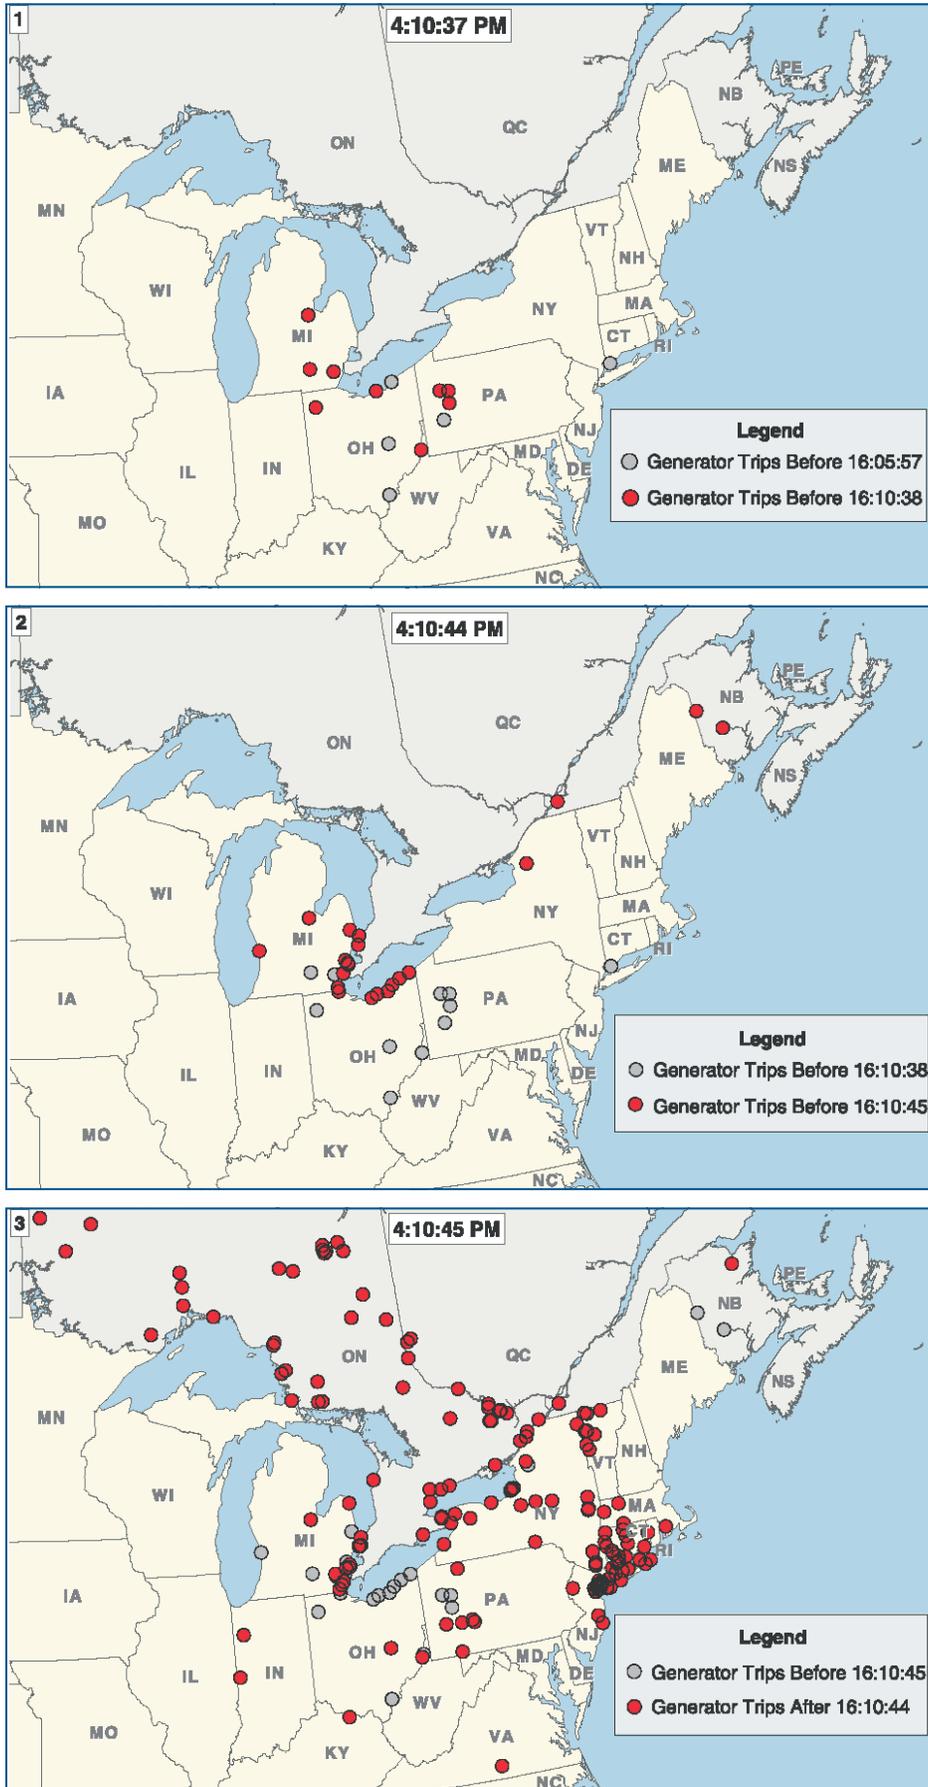
Figure 5.18. Power Plants Tripped During the Cascade

**Consequential trips.** Most of the unit separations fell in the third category of consequential tripping—they tripped off-line in response to some outside condition on the grid, not because of any problem internal to the plant. Some generators became completely removed from all loads; because the fundamental operating principle of the grid is that load and generation must balance, if there was no load to be served the power plant shut down in response to over-speed and/or over-voltage protection schemes. Others were overwhelmed because they were among a few power plants within an electrical island, and were suddenly called on to serve huge customer loads, so the imbalance caused them to trip on under-frequency and/or under-voltage protection. A few were tripped by special protection schemes that activated on excessive frequency or loss of pre-studied major transmission elements known to require large blocks of generation rejection.

The maps in Figure 5.18 show the sequence of power plants lost in three blocks of time during the cascade.

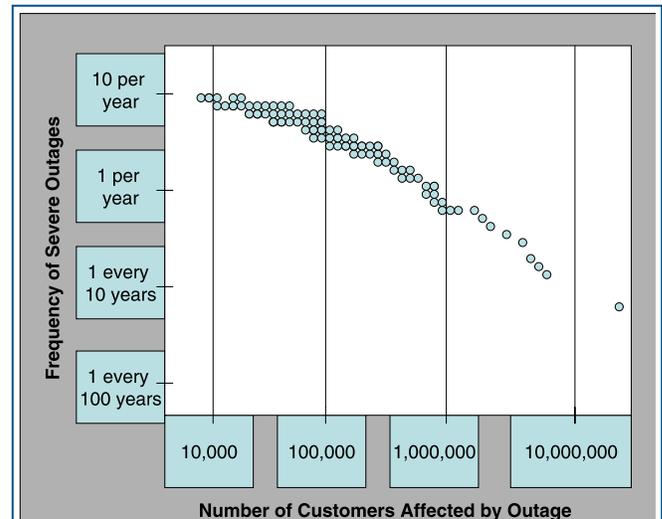
Figure 6.1. North American Power System Outages, 1984-1997

Short, localized outages occur on power systems fairly frequently. System-wide disturbances that affect many customers across a broad geographic area are rare, but they occur more frequently than a normal distribution of probabilities would predict. North American power system outages between 1984 and 1997 are shown in Figure 6.1 by the number of customers affected and the rate of occurrence. While some of these were widespread weather-related events, some were cascading events that, in retrospect, were preventable. Electric power systems are fairly robust and are capable of withstanding one or two contingency events, but they are fragile with respect to multiple contingency events unless the systems are readjusted between contingencies. With the shrinking margin in the current transmission system, it is likely to be more vulnerable to cascading outages than it was in the past, unless effective countermeasures are taken.

If nothing else changed, one could expect an increased frequency of large-scale events as compared to historical experience. The last and most extreme event shown in Figure 6.1 is the August 10, 1996, outage. August 14, 2003, surpassed that event in terms of severity. In addition, two significant outages in the month of September 2003 occurred abroad: one in England and one, initiated in Switzerland, that cascaded over much of Italy.
