2014 FIDVR Events Analysis on Valley Distribution Circuits

Engineering & Technical Services, Advanced Technology

June 19, 2015

2014 FIDVR Event Analysis on Valley Distribution Circuits

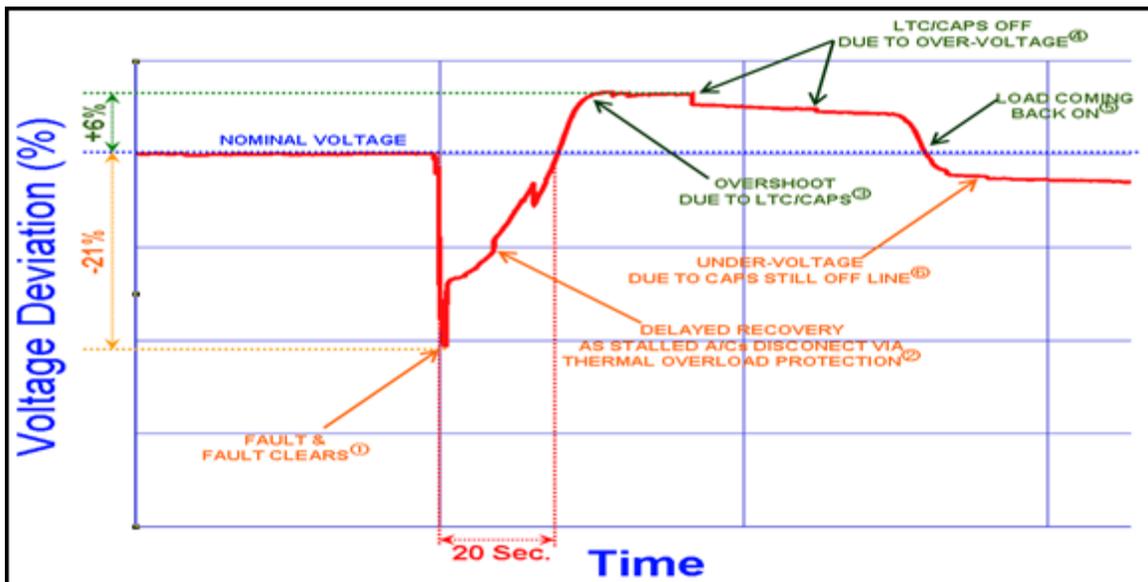
Figure 1.0.1 FIDVR Anatomy

FIDVR events have been typically recorded in the transmission system as in Figure 1.0.1 which shows the voltage being depressed to 79 percent during a system fault. The voltage is kept suppressed by the stalling of RAC and slowly recovers as the RAC's thermal overloads start opening, disconnecting the RAC from the system. The voltage does not stop at pre-fault voltage, but instead it keeps increasing. This incremental change is due to the high amount of customer load disconnecting from the system and system capacitors remaining online. The system voltage starts decreasing to pre-fault levels when the system capacitors disconnect due to the over-voltage and customer load starts coming back to the system.

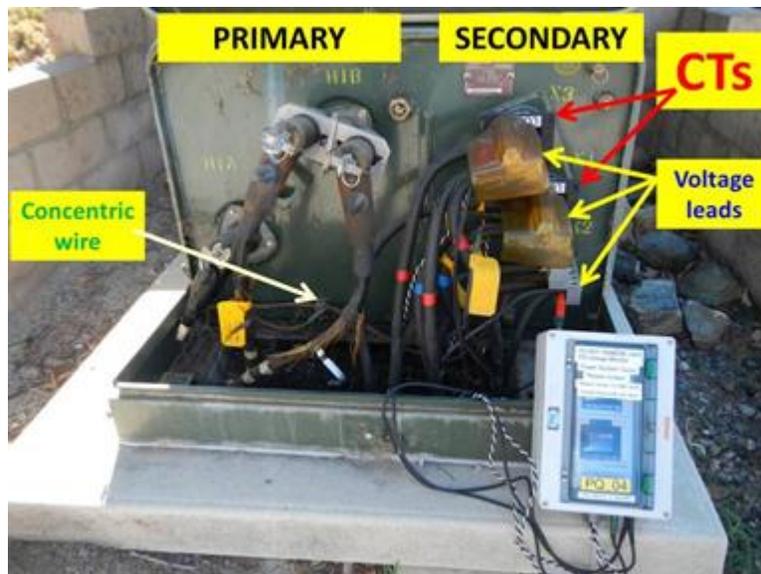
Figure 4.0.2 PQ Recorder Field Installation in a Pad Mount Transformer

One of the actual residential padmount transformer installations is shown in Figure 4.0.2. The primary side (6.9 kV) has two boot connections where one goes into one pad-mount transformer and the other leaves, going to a different pad-mount transformer.

The secondary side of the transformer has three terminal blocks with three cables (L1, L2, and neutral rated at 240 V line-to-line) going to customer main panels. These terminal blocks contain the CTs and voltage leads for the installed PQ device. The neutral is connected to ground at this point.

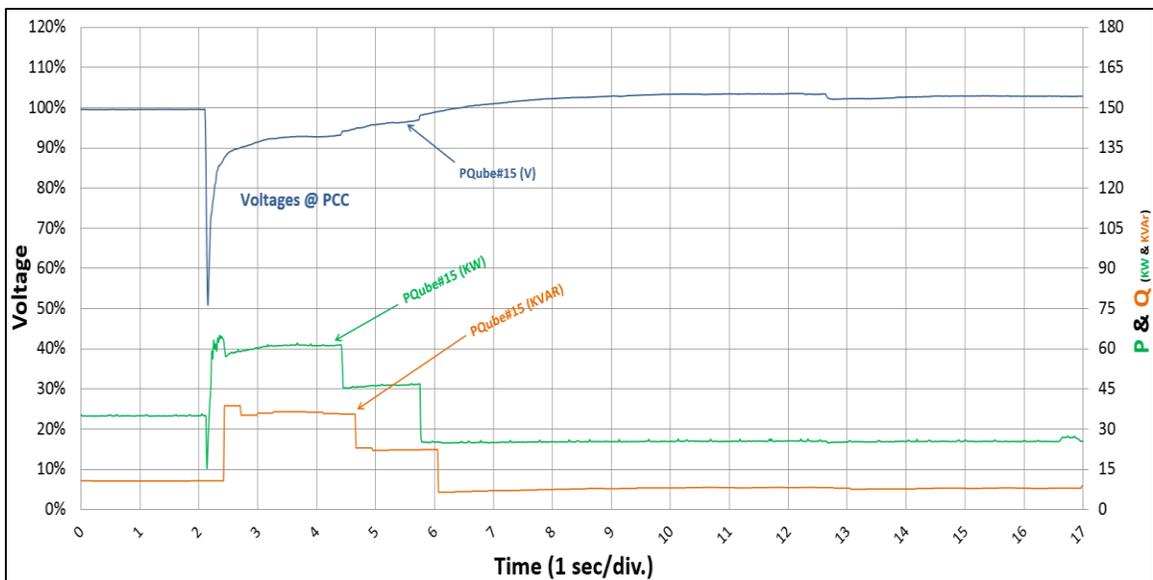
Figure 6.2.2 FIDVR Event #2 (September 12, 12:55 PDT) RMS Data [PQ 15]

The Grid Control Center (GCC) reported a fire of undetermined origin burning under and past a 500 kV line on the system. At 12:55, a fault was indicated and the 500 kV line relayed as a result. The RMS data for Event #2 shown in Figure 6.2.1 exhibits these characteristics:

- The event spread through the distribution system as evidenced by the multiple PQ device recordings at different monitoring locations
- During the fault captured, the voltages at the PCC drop to as low as 51% of nominal where RACs appear to stall at one of PQ devices
- Real power (P) and reactive power (Q) at PQ 15 increased as such
 - $P = 1.6X$ at $V = 88\%$ within 1 second after the fault
 - $Q = 3.7X$ at $V = 88\%$ within 1 second after the fault
- The various circuits took approximately 4.5 seconds respectively for voltage to recover to their pre-event conditions
- Stalled loads begin disconnecting a couple seconds after the fault
- Approximately 29% of the load was lost due to RAC's thermal protection by the 7 second mark shown on Figure 6.2.2
- The loss of load provoked a maximum over-voltage of 5% above nominal on the assorted distribution circuits

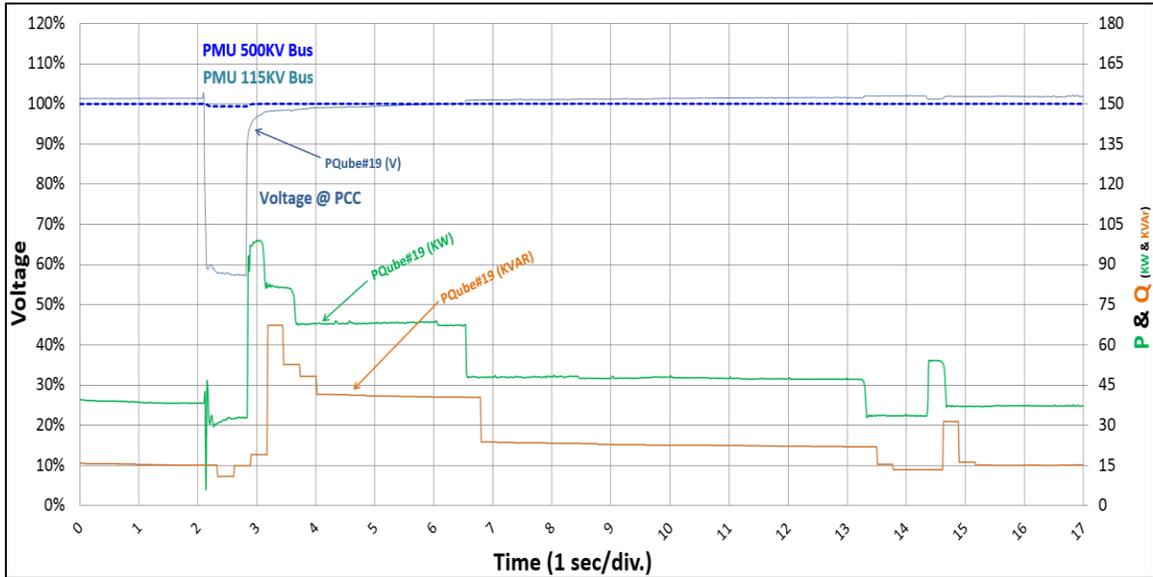
Figure 7.2.1 Event #2 (June 30, 18:49 PDT) RMS Data [PQ 19]

No information was documented by the GCC for this specific event. The RMS data for this event shown in Figure 7.2.1 exhibited the following characteristics at the monitoring location of PQ 19 on phase C of the Valley 115 kV section C&D bus:

- Stalled load(s) begins dropping approximately 1 second after the voltage fault and continues until 13% of the pre-event load is lost
- The sudden increase in P & Q after the 14 second mark is likely the result of inrush from restarting load

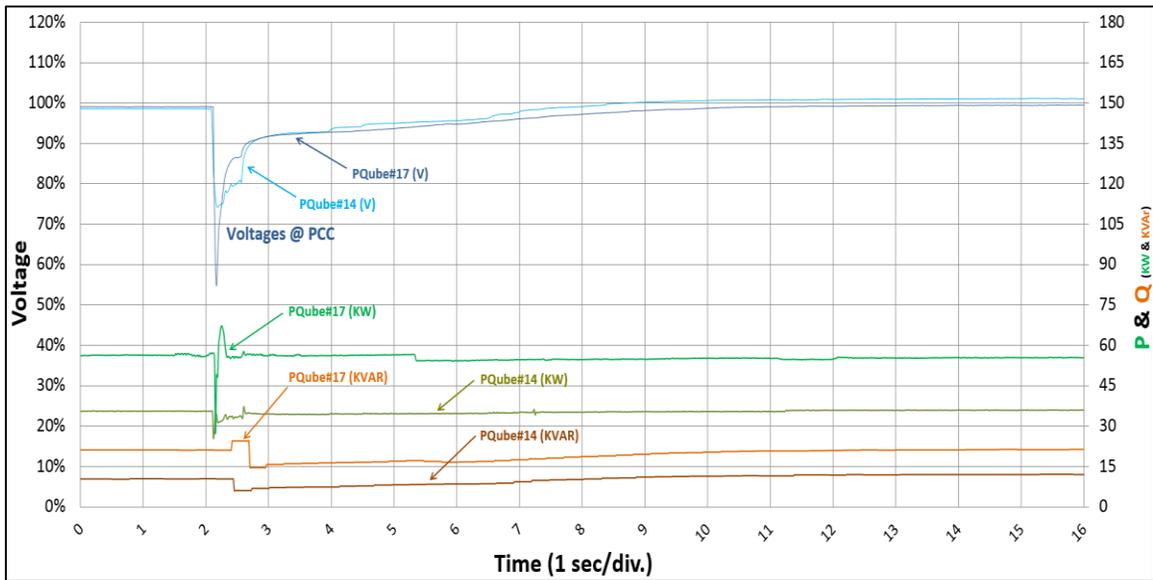
Figure 7.7.1 Event #7 (September 16, 14:36 PDT) RMS Data [PQ 14 and 17]

The following event was captured from PQ devices 14 and 17 located on different phases within the section C&D bus of the Valley system. The GCC reported that a 115 kV line relayed during a storm and numerous distribution lines relayed and reclosed resulting in approximately 50 MW of voltage sensitive load disconnected itself during the event. The RMS data for this event shown in Figure 7.7.1 exhibited the following characteristics:

- The event spread through more than one of the distribution systems as evidenced by the multiple PQ device recordings
- Voltage decreased as low as 55% of nominal for PQ 17 and 75% for PQ 14
- After the fault, the voltage took nearly 6.5 seconds to recover to its pre-event values at the PCC for PQ 17
- Despite the minor voltage recovery profile, **there does not appear to be any load stalling behavior at either of the two monitoring locations**
- The voltage profile and GCC report imply stalling may have occurred at adjacent padmount locations and/or adjacent circuits without PQ devices. However, this cannot be confirmed since voltage data from neighboring padmounts or circuits was not observed at this resolution.
